AIRCRAFT ACCIDENT REPORT

UNCONTAINED ENGINE FAILURE
DELTA AIR LINES FLIGHT 1288
MCDONNELL DOUGLAS MD-88, N927DA
PENSACOLA, FLORIDA
JULY 6, 1996

**Adopted: January 13, 1998
Notation 6725C**

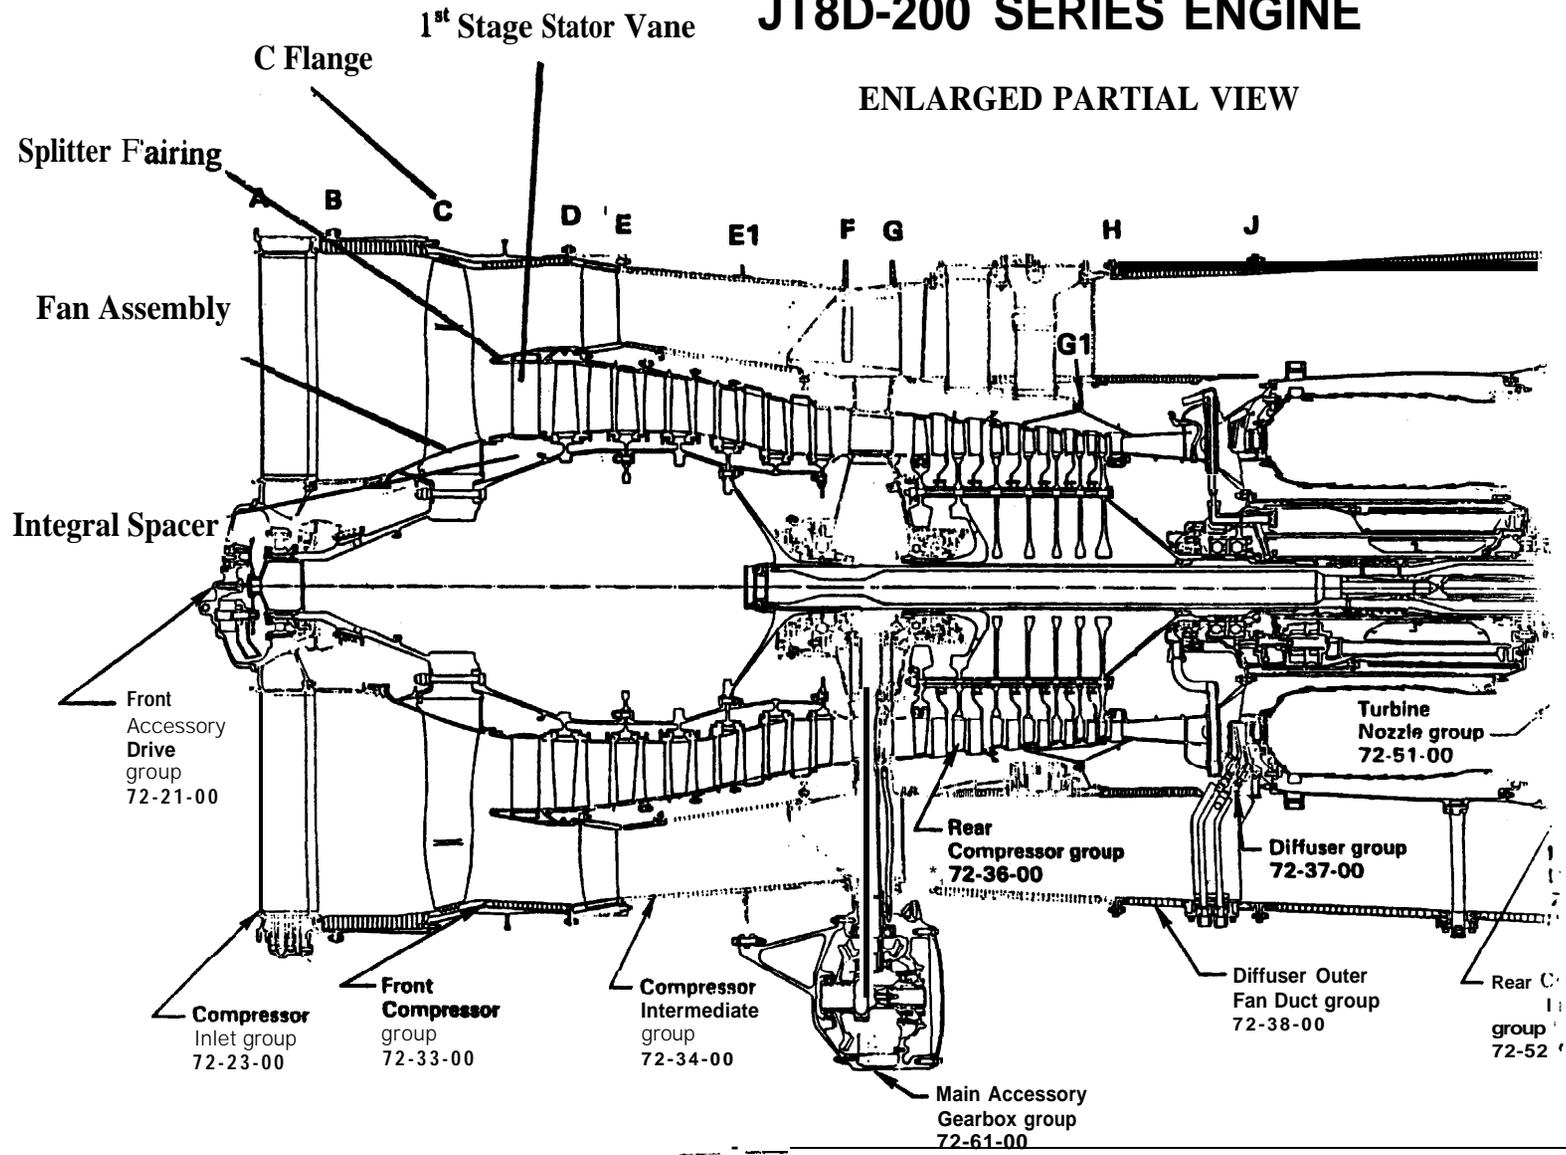
The outer engine case separated at the C flange (see figure 7).³¹ Forward of the C flange, the case remained attached to the cowl. The case was torn and fragmented in two areas (centered at the 1 o'clock and 7 o'clock positions) between the C and D flanges. The 1 o'clock position was missing a segment from the 12:30 to 2 o'clock positions. The case was intact but had been torn loose from the D flange between the 2 o'clock and 3 o'clock positions. A 14-inch circumferential part of the fan rear case was found on the runway 61 feet to the right of the centerline and 441 feet from the runway threshold. Acoustic honeycomb in the fan case area was ripped, torn, or missing in many places. The splitter fairing³² (see figure 7) was missing from the 1 o'clock to the 7 o'clock position. A torn piece of the splitter remained attached at the 5 o'clock position. Twelve first-stage stator vanes³³ were present on the remaining splitter fairing. The inner diameter ends of the vanes were separated from the inner shroud and bent in the direction of rotation.

Figure 7.—Enlarged, partial view of outer engine case of JT8D-200 series engine.
