**Turkish Airlines DC-10 TC-JAV**  
**Report on the accident in the**  
**Ermenonville Forest, France**  
**on 3 March 1974**

ACCIDENT TO  
TURKISH AIRLINES DC-10 TC-JAV  
IN THE ERMENONVILLE FOREST  
ON 3 MARCH 1974

FINAL REPORT

February 1976

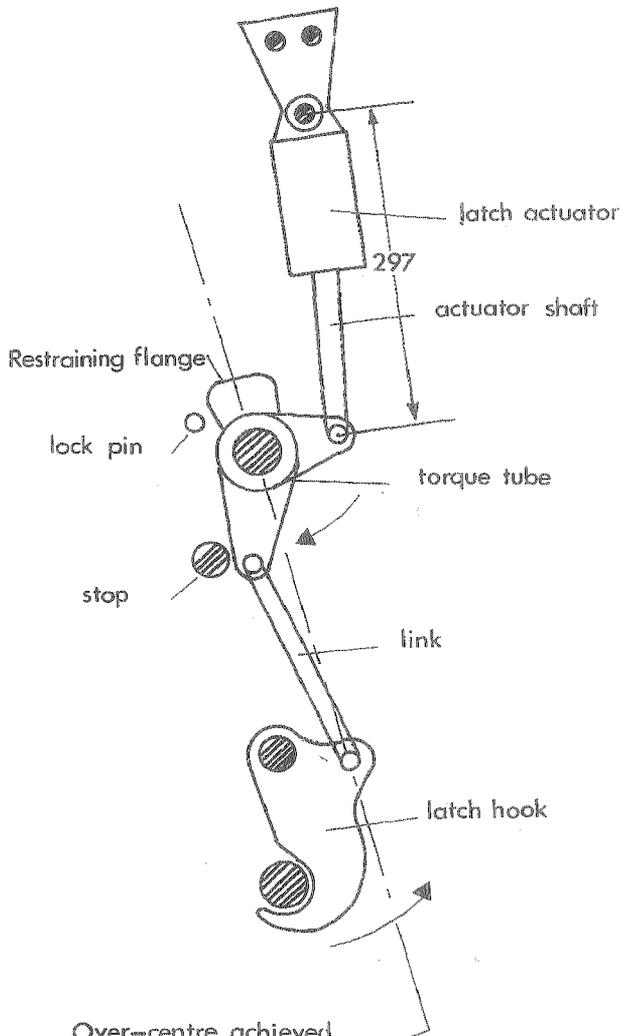
Fig. 1

Under these conditions, the chain of operation between actuator and latches is not irreversible: any force exerted on the latches is re-transmitted to the actuator instead of being absorbed by the 4 stops provided for that purpose (fig 1).

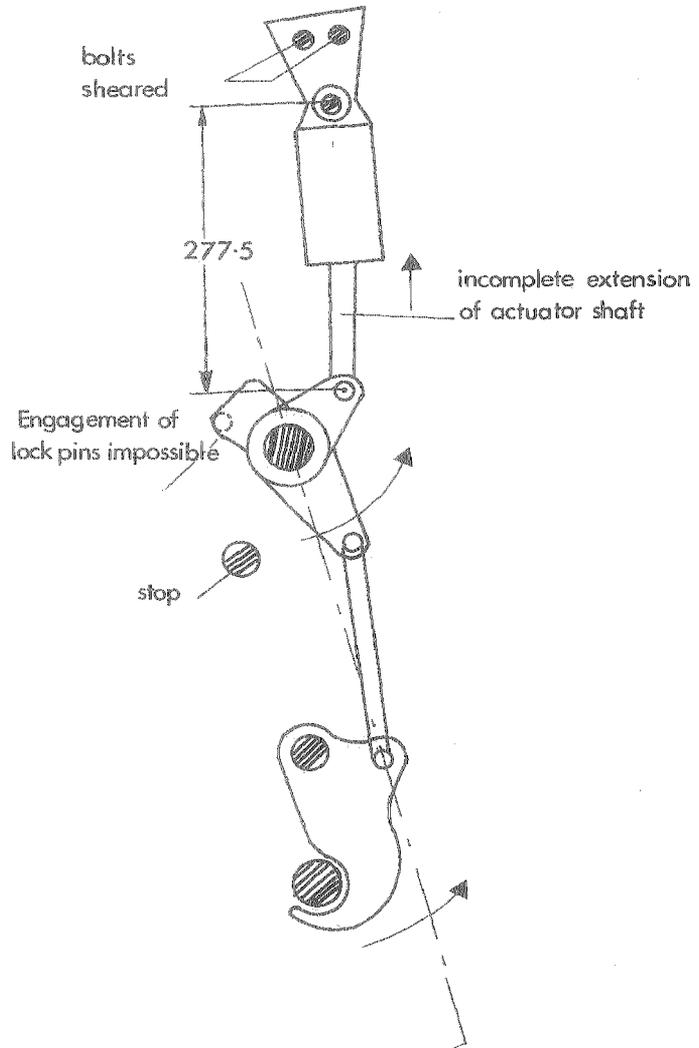
Fig 2

Over-centre not achieved  
System reversible  
Incorrect closure

Expert examination of the wreckage of the door, of which the closing system (latches, latch actuator and operating mechanism) was found in good condition, has revealed various deficiencies. The latter were such that the aircraft's take-off was undertaken with the latches very near to their correct position when closed, but at the same time the links which control the latches had not achieved over-centre (fig 2) and as a natural consequence the lock pins could not have been engaged.

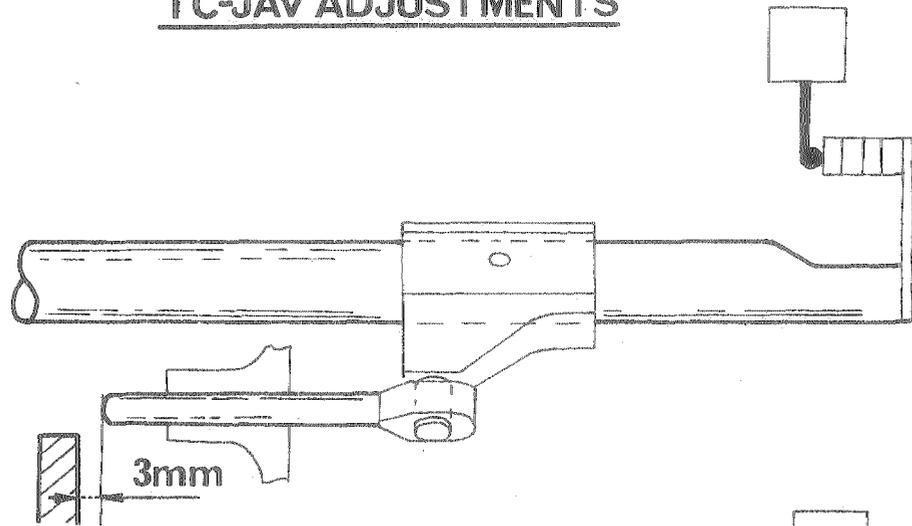
FIG.3

In conclusion, the adjustment of the lock limit warning switch was defective and caused the flight deck warning light to go out when the latches were not necessarily closed.

In brief, examination of the wreckage of the door of TC-JAV revealed defective adjustment of the lock limit warning switch. In addition, after the rods of a new door of the same definition had been adjusted to the dimensions measured on TC-JAV, it could be judged that the adjustment of the lock pins was likewise incorrect in the locked position.

TC-JAV ADJUSTMENTS

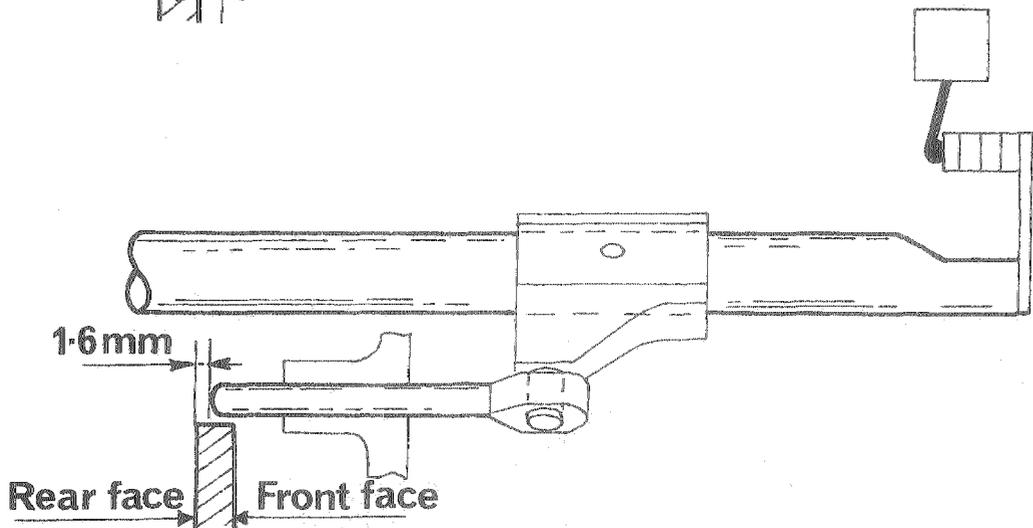
FIG.4

Because of the defective adjustment of the extreme positions of the lock tube, the handle could be closed without excessive force, although the latches were not completely closed.

Position at which flight deck visual warning light is switched off

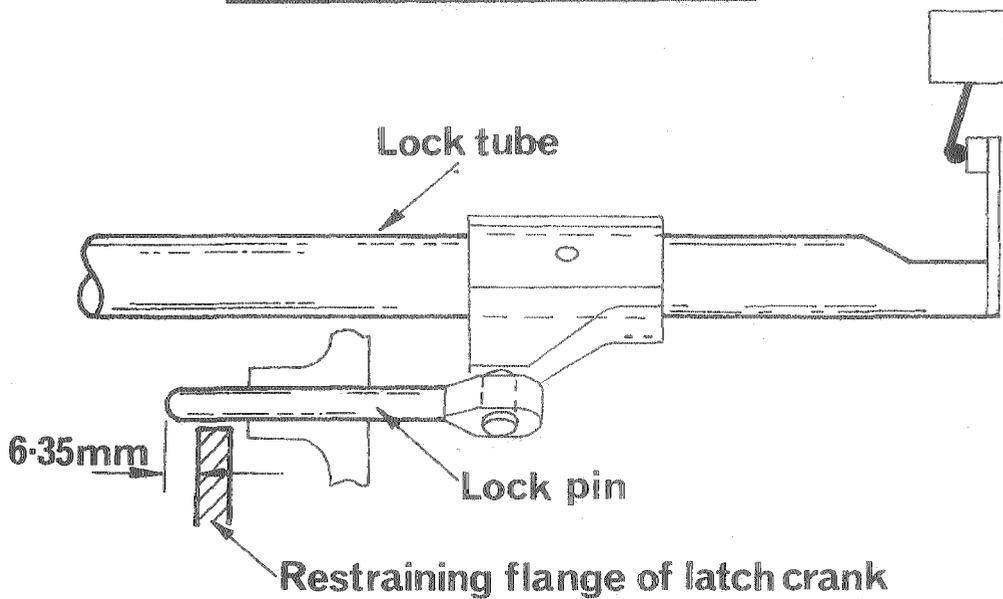
FIG.5

CORRECT ADJUSTMENTS

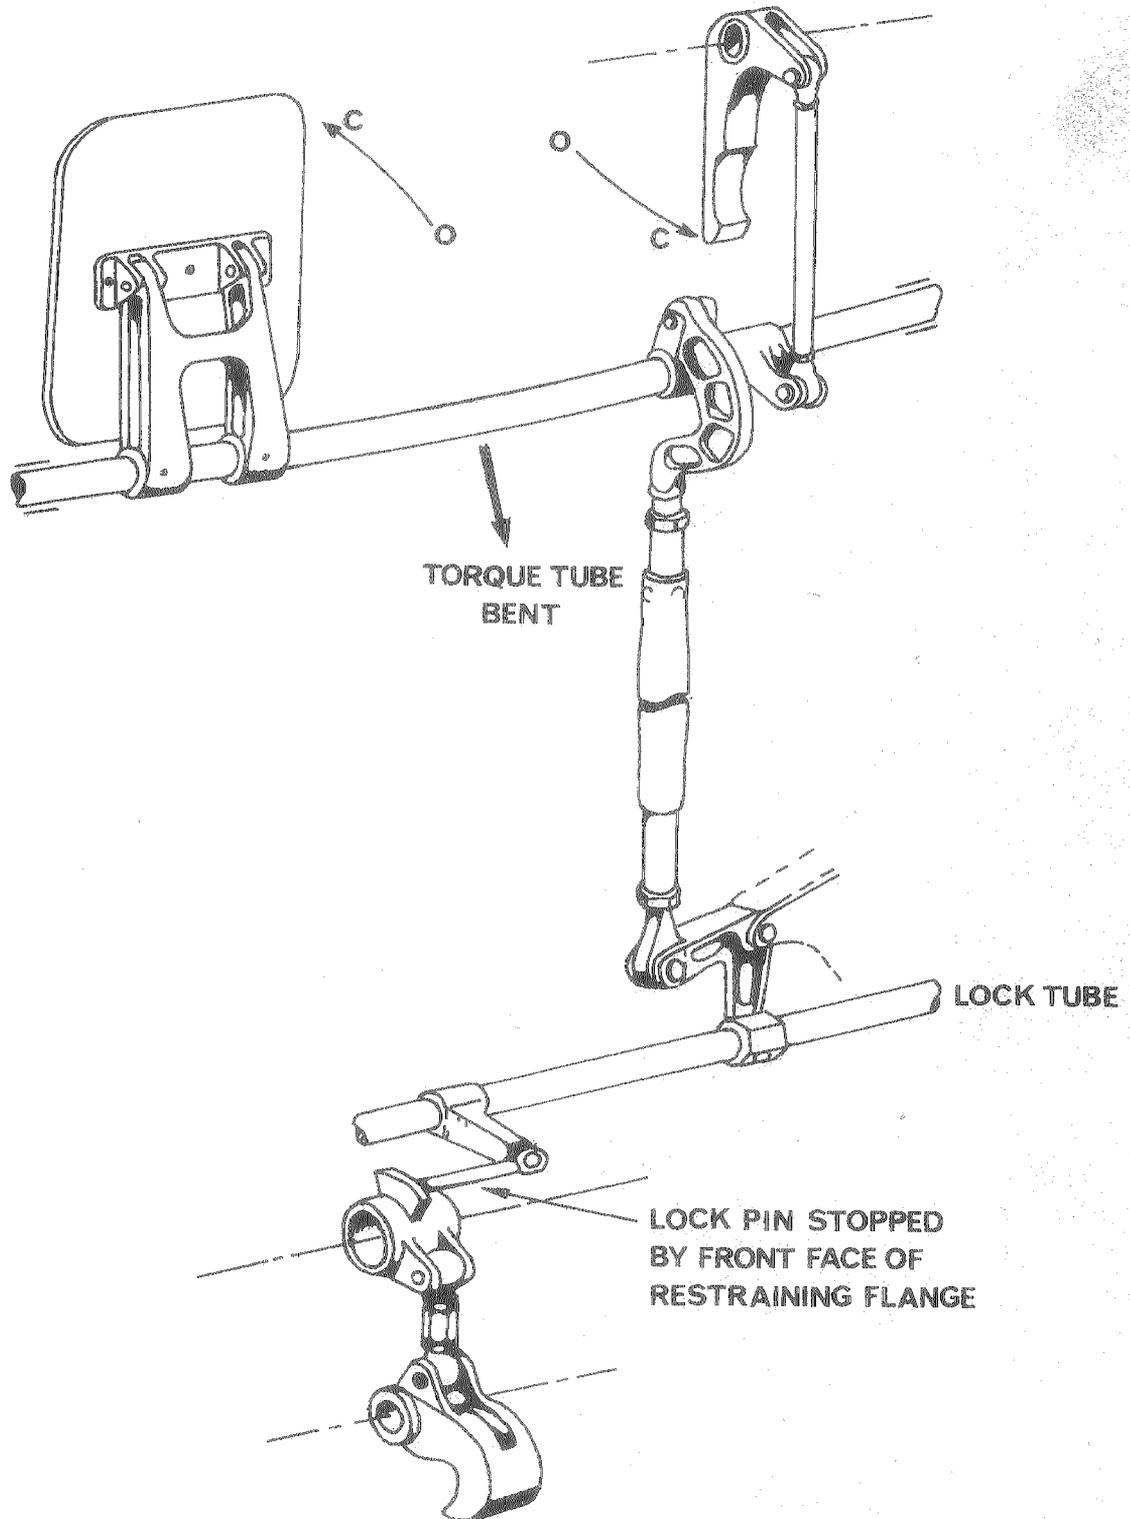
FIG.7

# FORCED CLOSURE
