**AIRCRAFT ACCIDENT REPORT**

UNITED AIR LINES, INC.  
BOEING 727, N7030U  
SALT LAKE CITY, UTAH  
NOVEMBER 11, 1965

SYNOPSIS

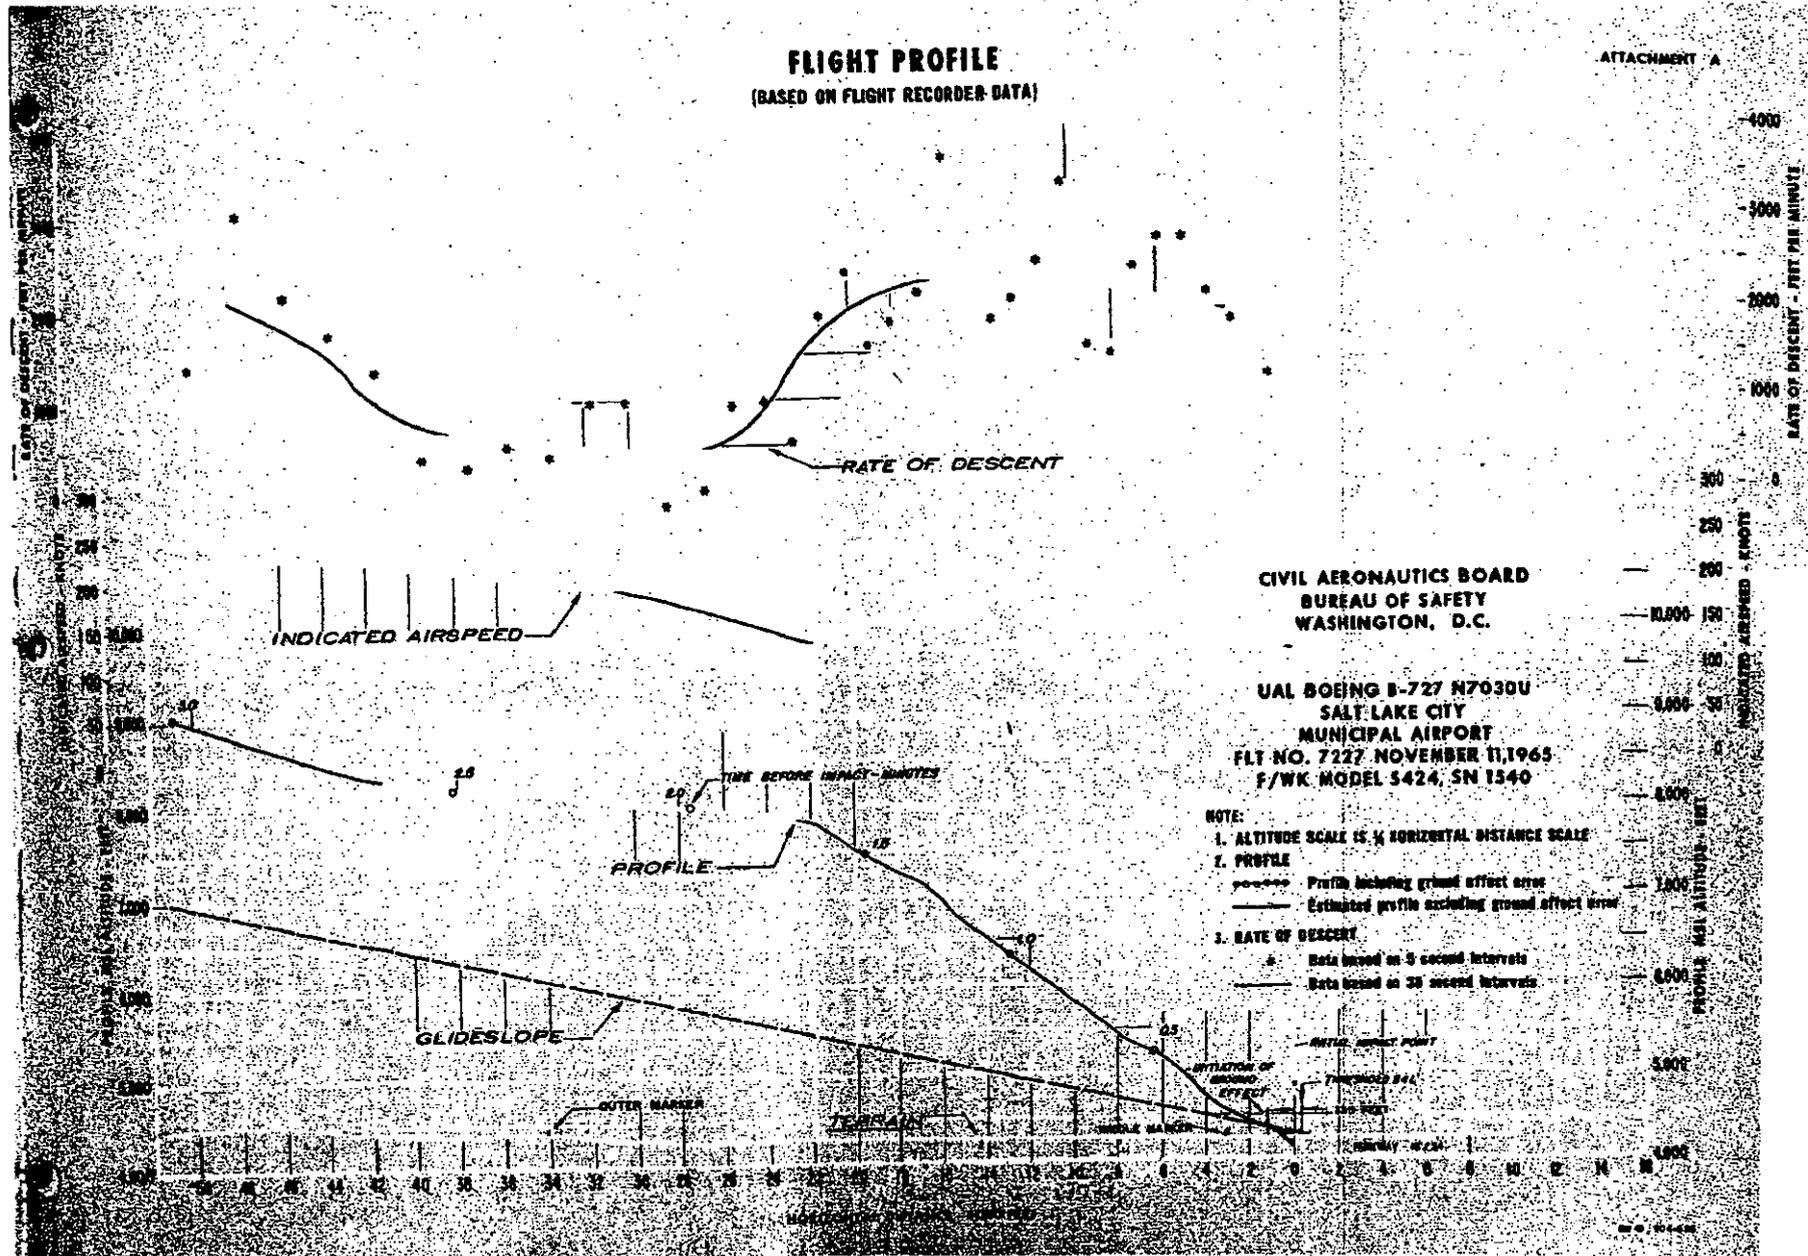
ATTACHMENT A

(BASED ON FLIGHT RECORDER DATA)
