CFM56-3

Aircraft Type and Registration:	Boeing 737-400, G-OBME
No & Type of Engines:	2 CFM 56-3C high by-pass turbo-fan engines
Year of Manufacture:	1988
Date and Time (UTC):	8 January 1989 at 2025 hrs
Location:	Kegworth, near East Midlands Airport, Leicestershire
Type of Flight:	Scheduled passenger
Persons on Board:	Crew - 8 Passengers - 117 + 1 infant
Injuries:	Crew - 7 (serious) Passengers - 47 (fatal). 66 + 1 infant (serious) 1 (minor) 4 (minor)
Nature of Damage:	Aircraft destroyed
Commander's Licence:	Airline Transport Pilot's Licence
Commander's Age:	43 years
Commander's Total Flying Experience:	13180 hours (of which 765 were on Boeing 737-300/400 types)
Information Source:	AAIB Inspector's Investigation under the Civil Aviation (Investigation of Accidents) Regulations 1983

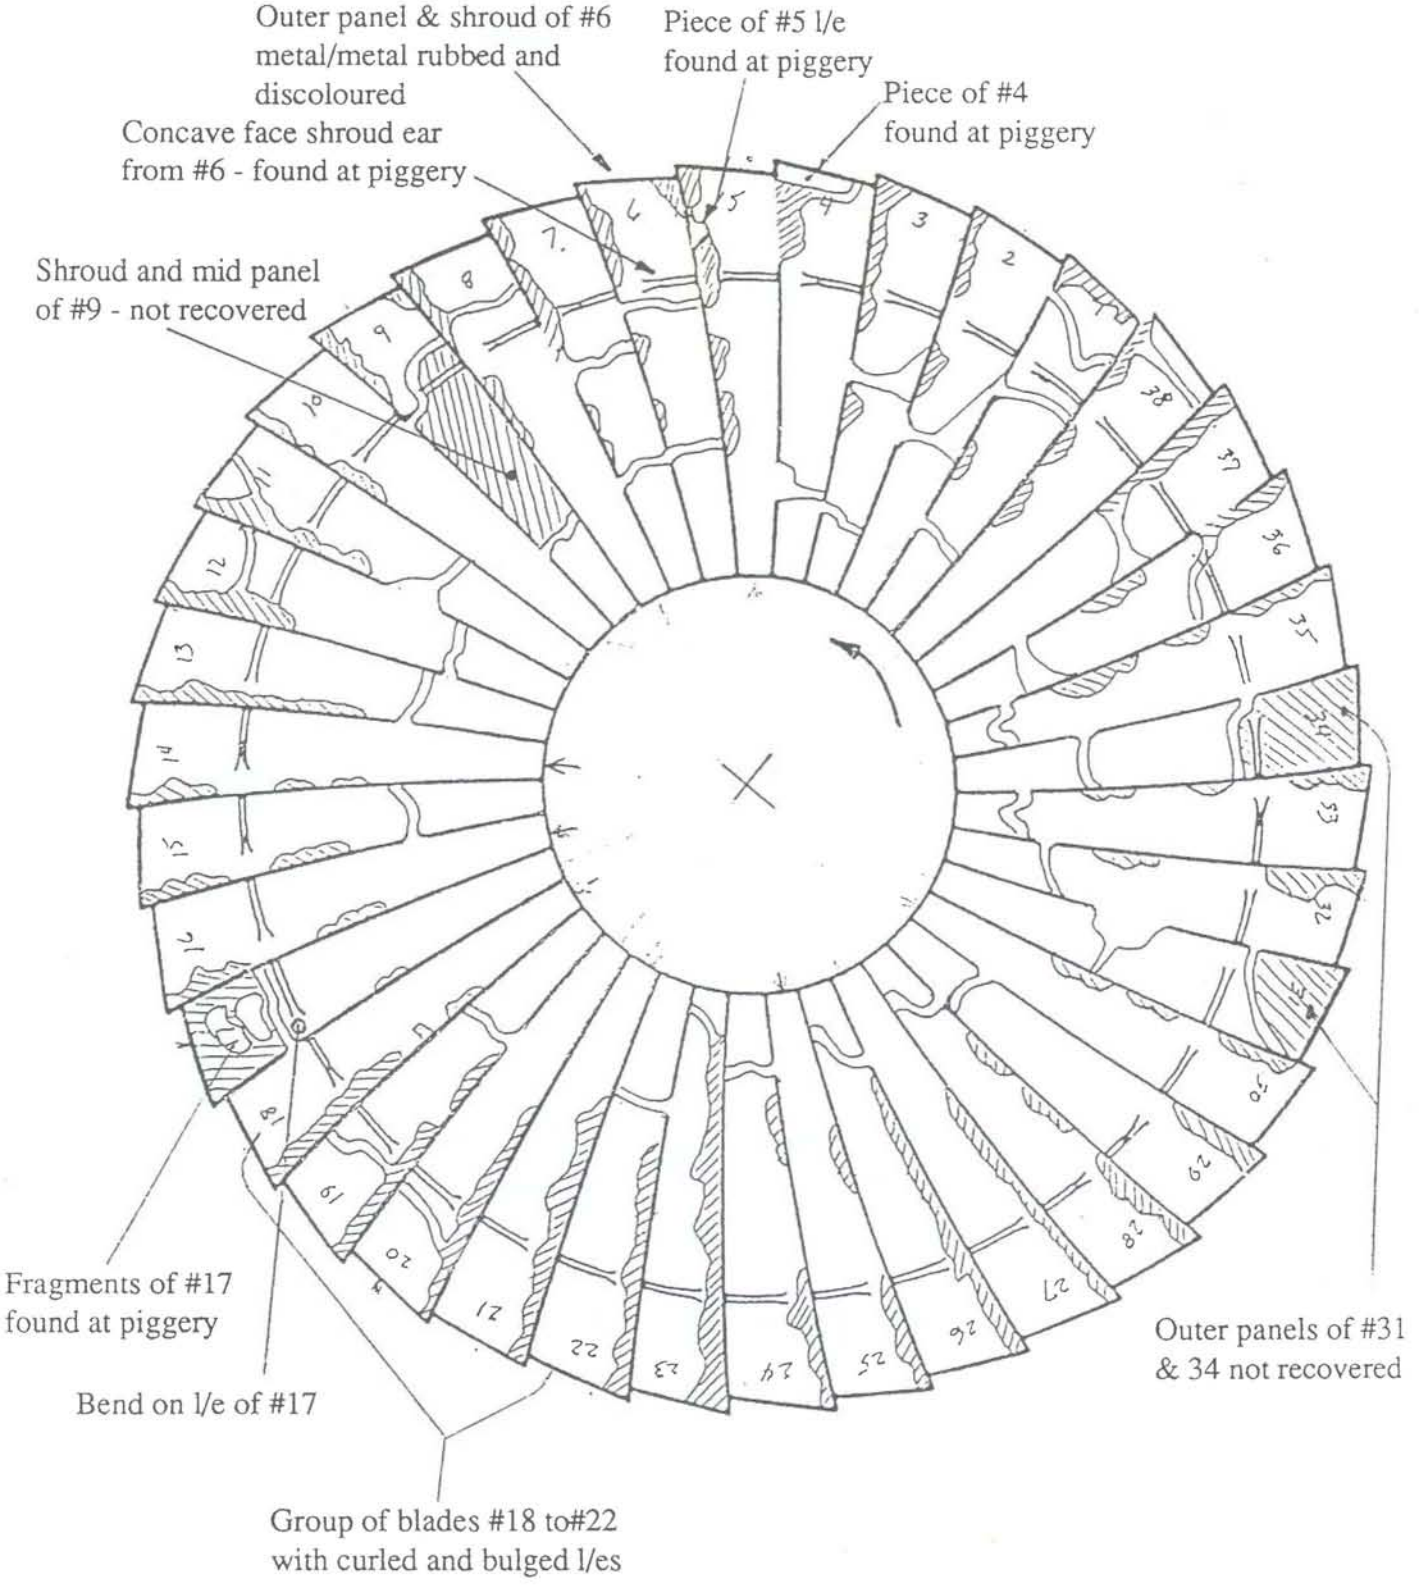
Appendix 1
Figure 2

Fragmentation and other damage features of the fan of No.1 engine from G-OBME

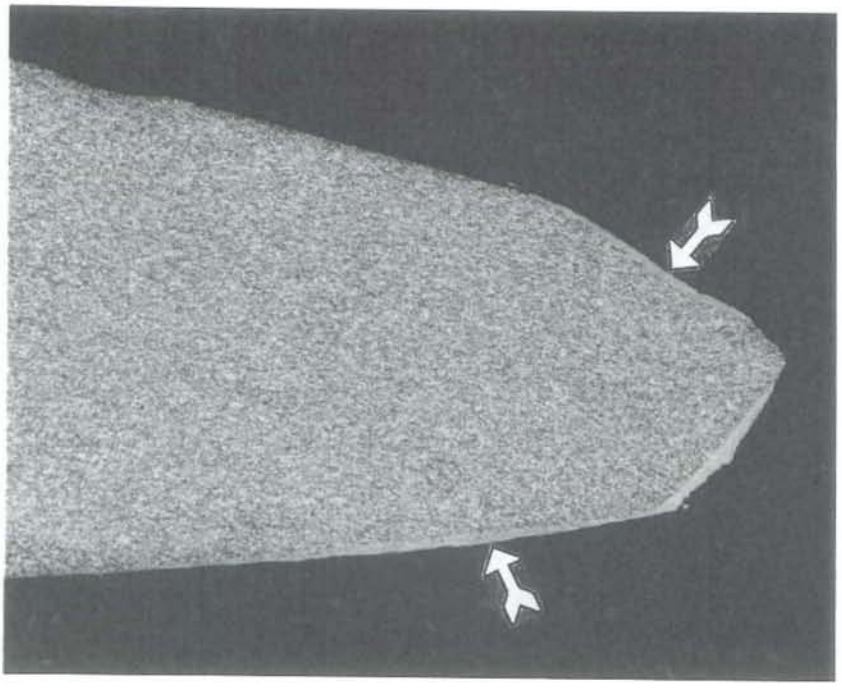
Figure 3

Microsection through the leading edge of blade 17 immediately below the plane of the fatigue crack.

This shows the even microstructure of the blade material as a whole and where the microstructure has been modified by high energy impacts.

The arrows point to the pressure (lower) and suction face impact facets where a shallow modified layer can be seen. The leading edge itself shows a much deeper bright modified layer.

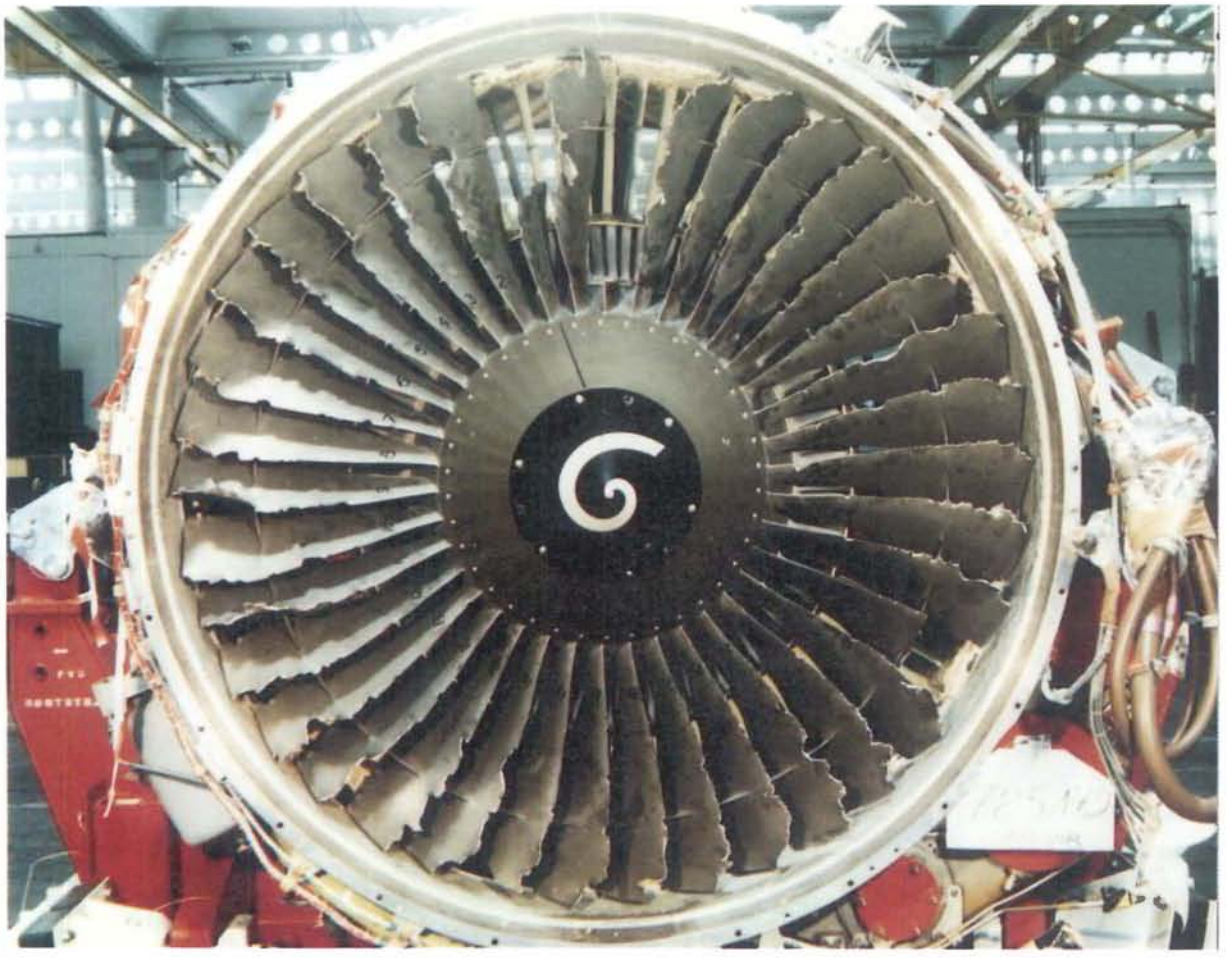
Figure 4(a)

View on front of fan of G-BNNL after in-flight fan blade outer panel separation showing the very severe leading edge damage to all the remaining blades.

Note also, at the 12 o'clock position where a full blade and a half blade have been broken away.

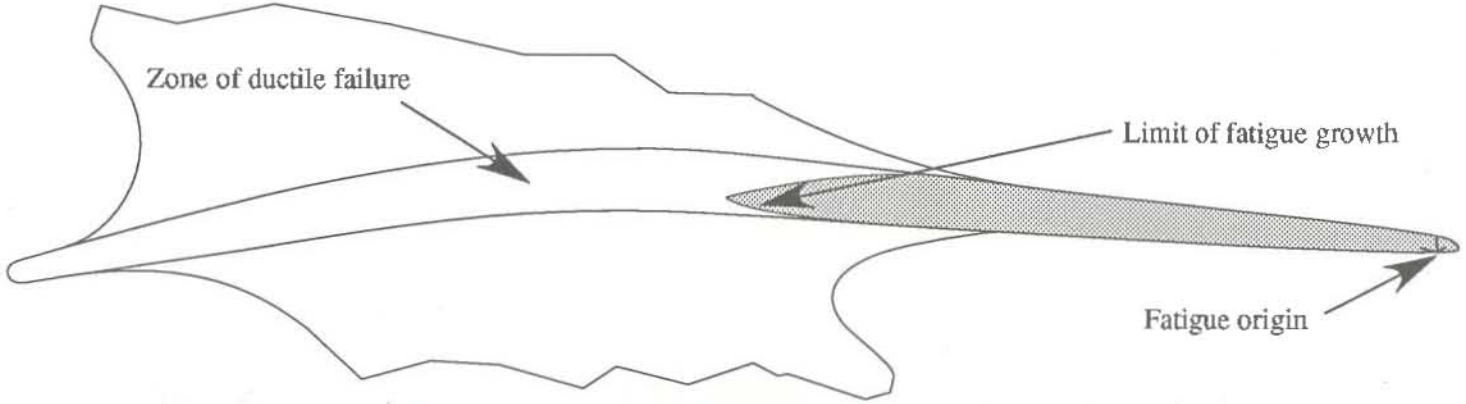
Appendix 1 Fig 5

Features of fan blade fracture from G-OBME

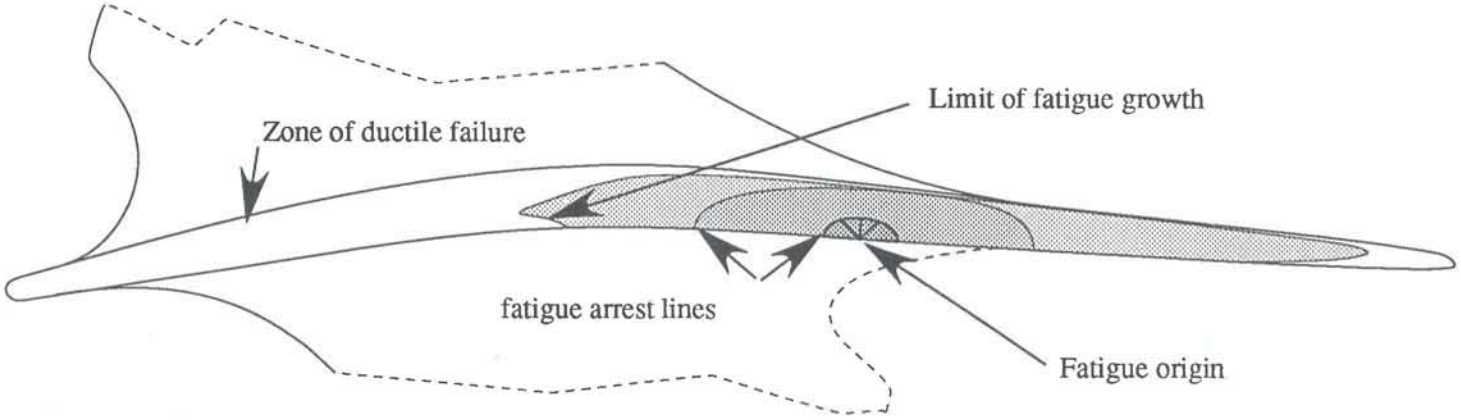
Appendix 1 Fig 6

Features of fan blade fracture from G-BNNL

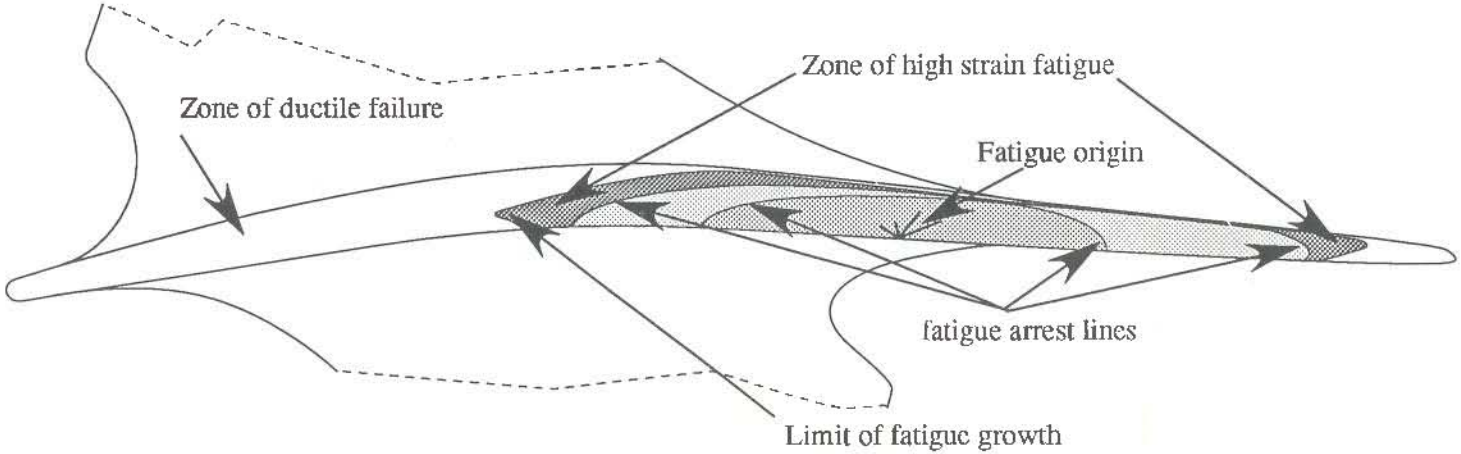
Appendix 1 Fig 7

Features of fan blade fracture from G-OBMG

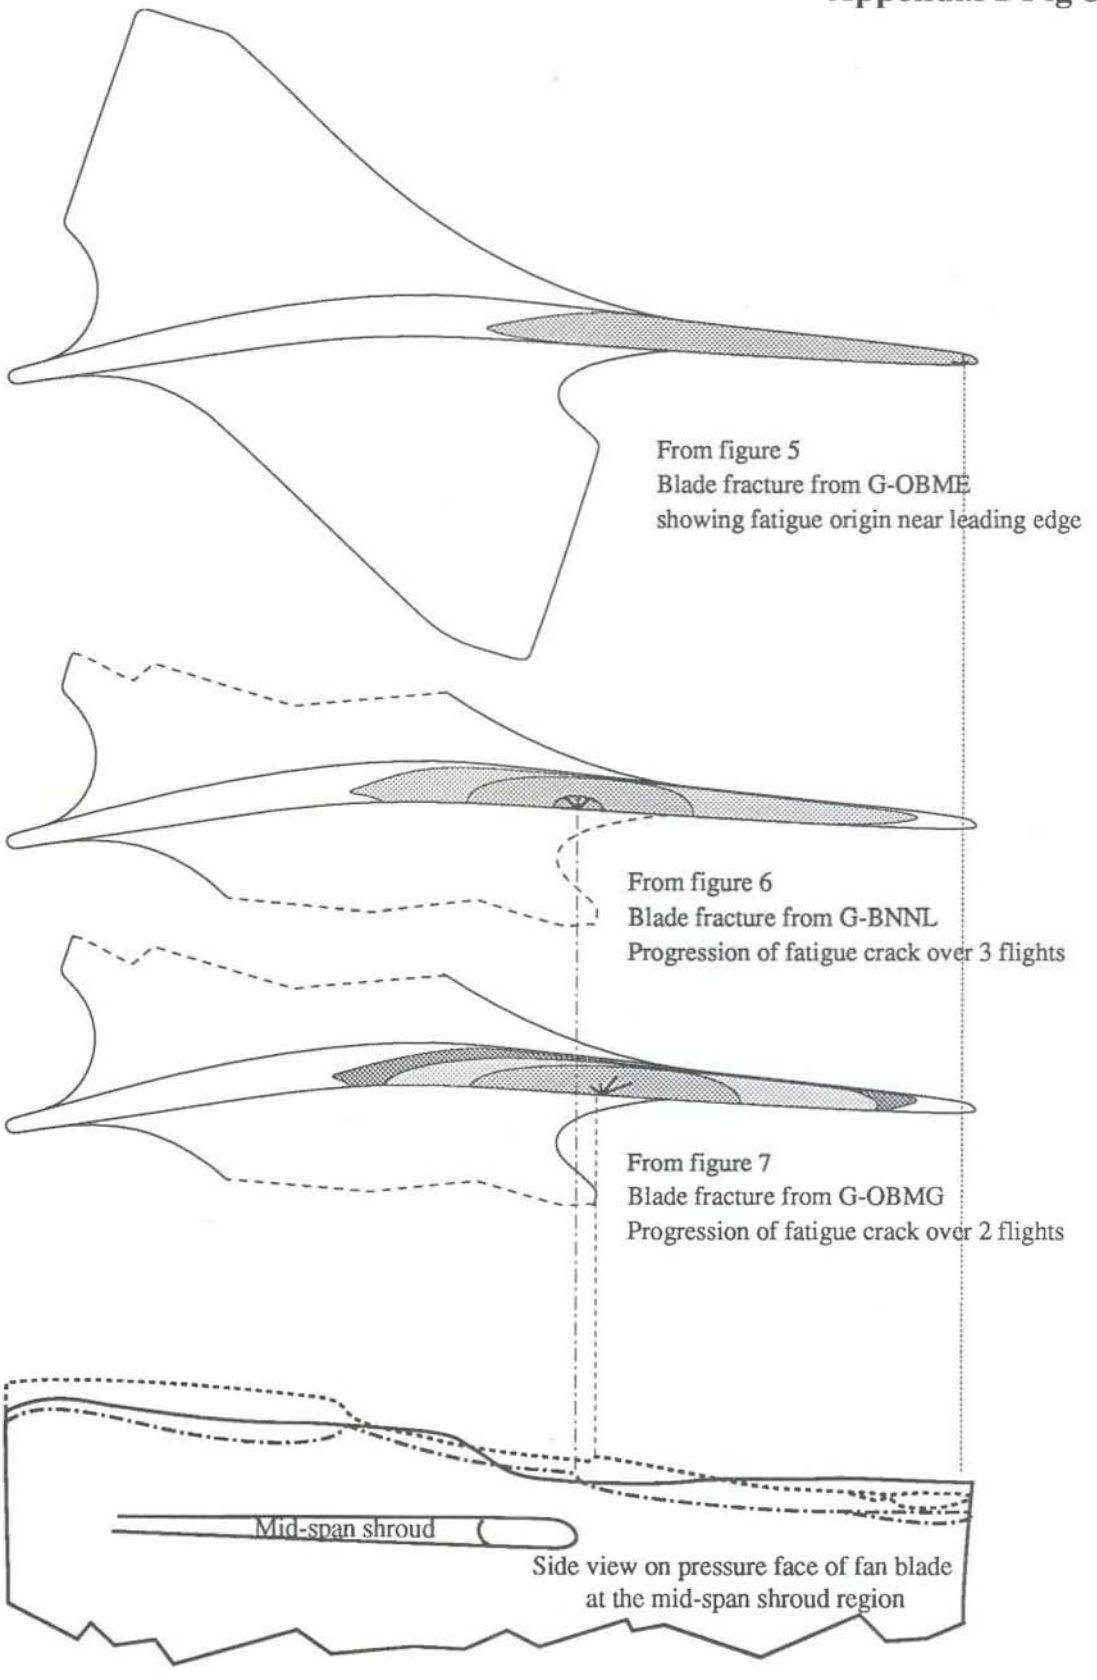
Appendix 1 Fig 8

Comparison of fracture lines on 3 fan blades

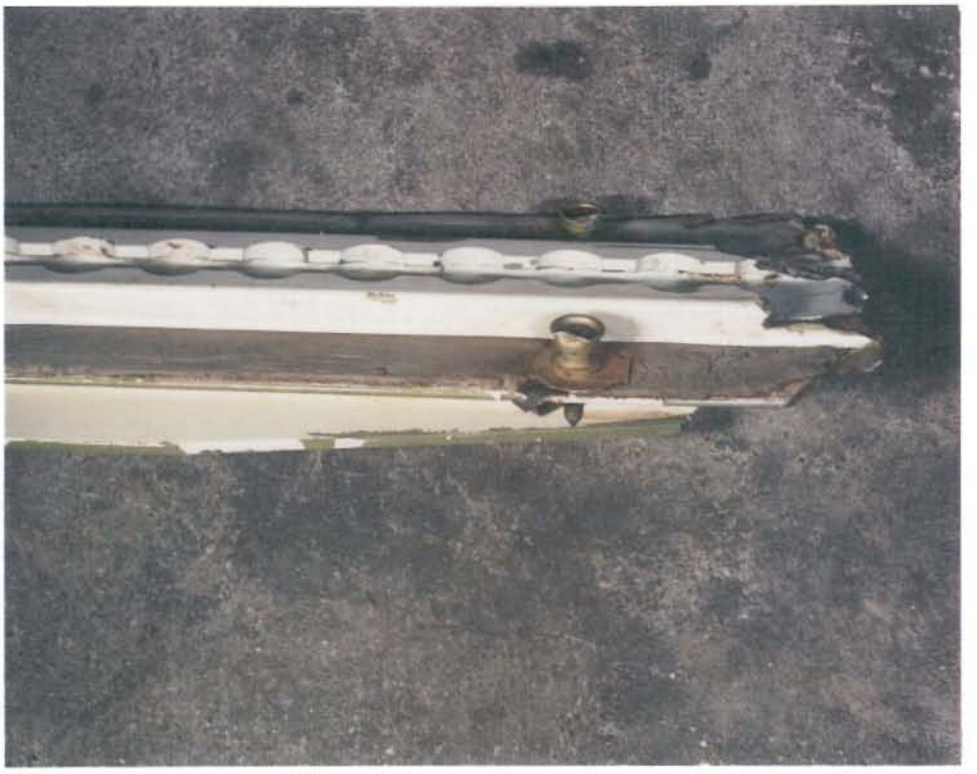
Appendix 3, figure 1 - Seat track, forward fuselage

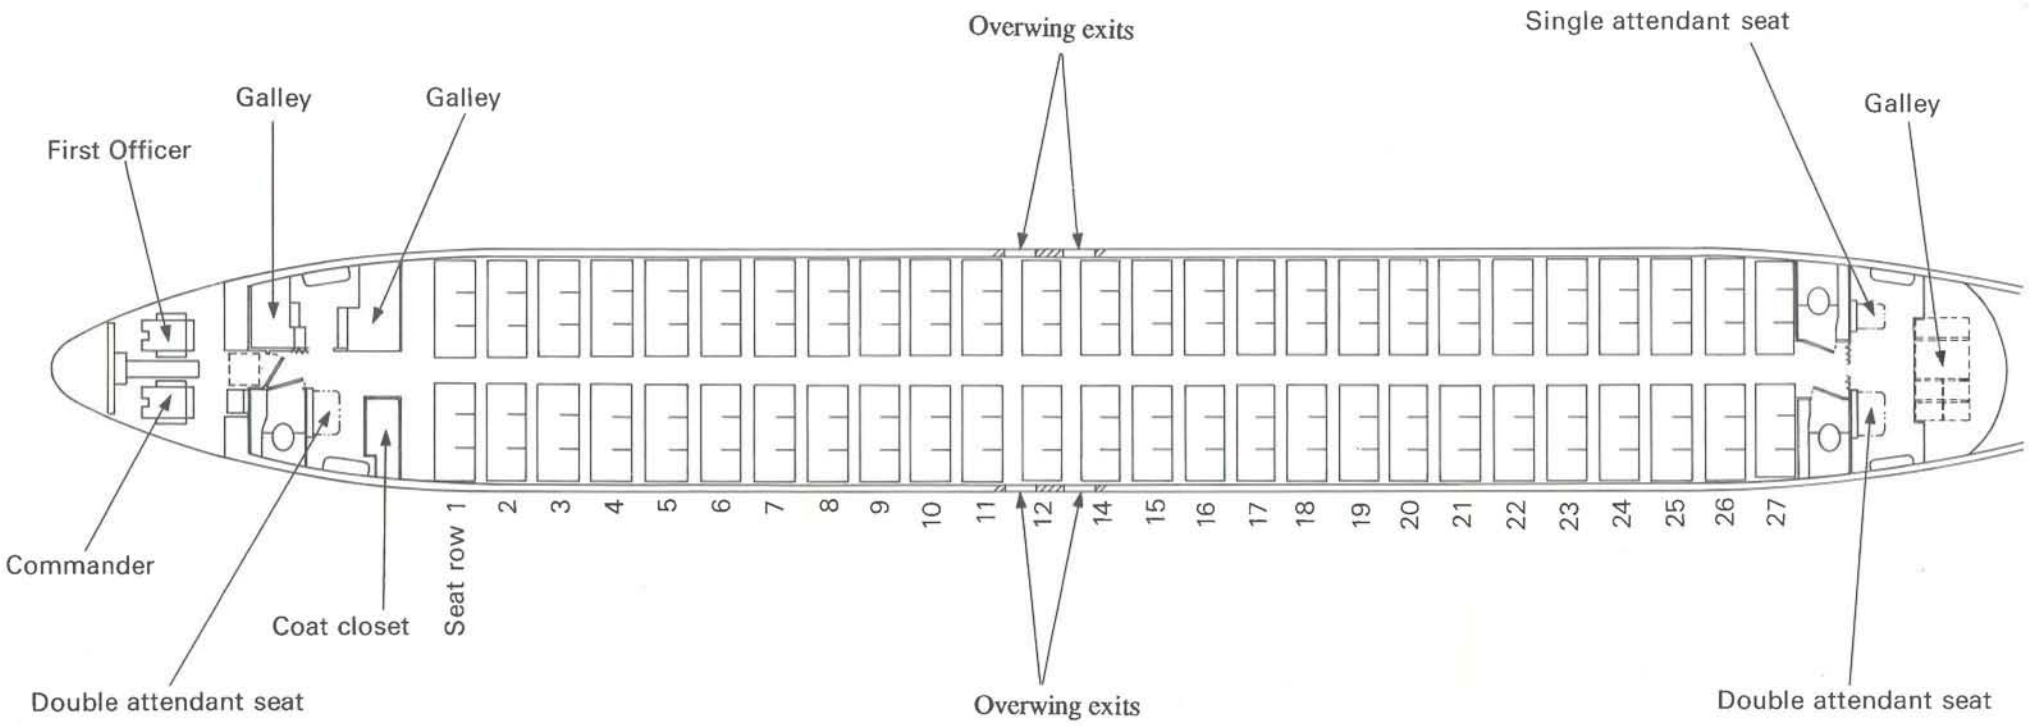
Appendix 3 Figure 3 G–OBME seating configuration

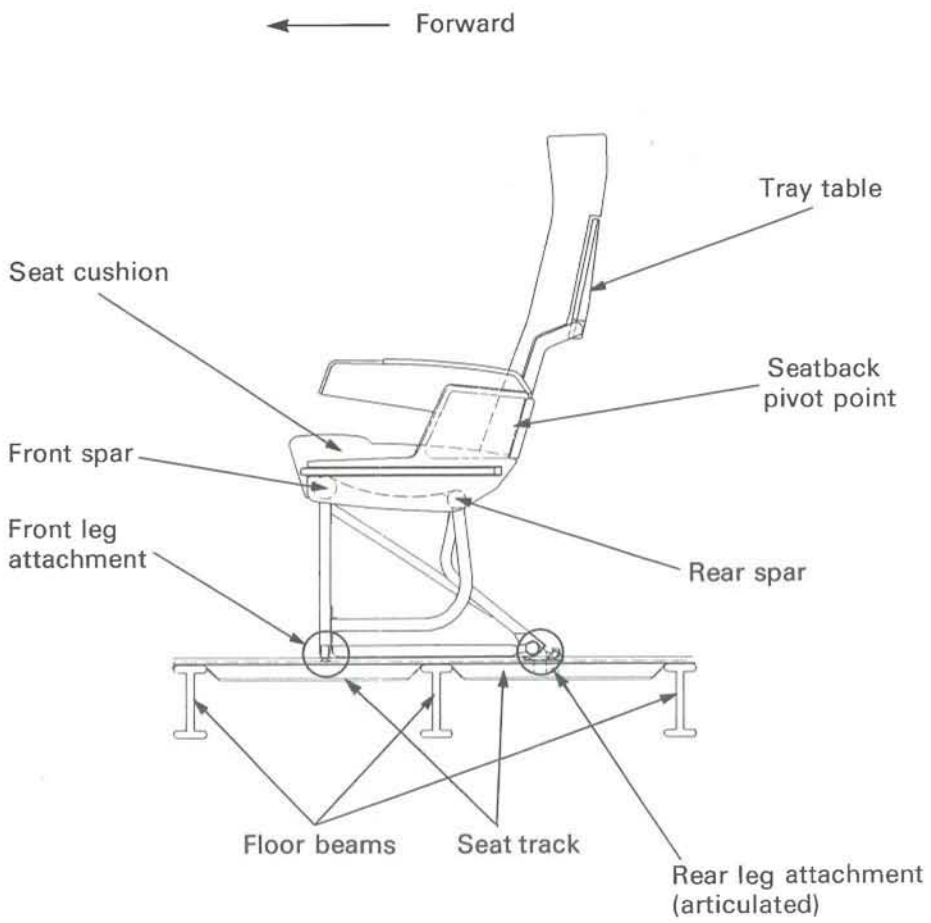
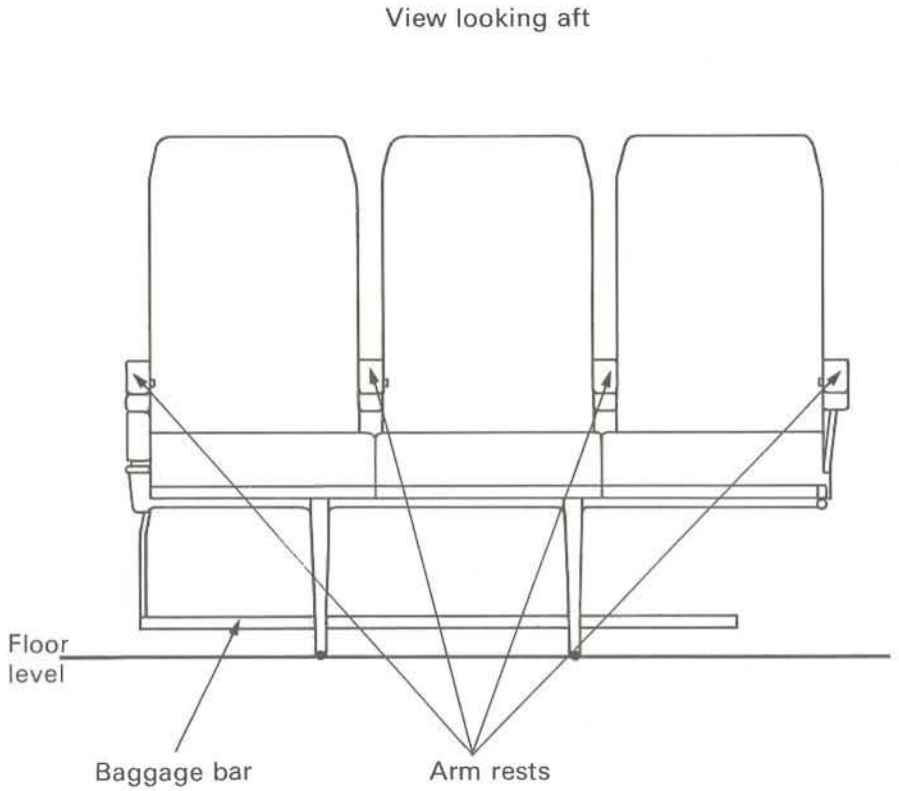
Appendix 3 Figure 4 Passenger triple seat

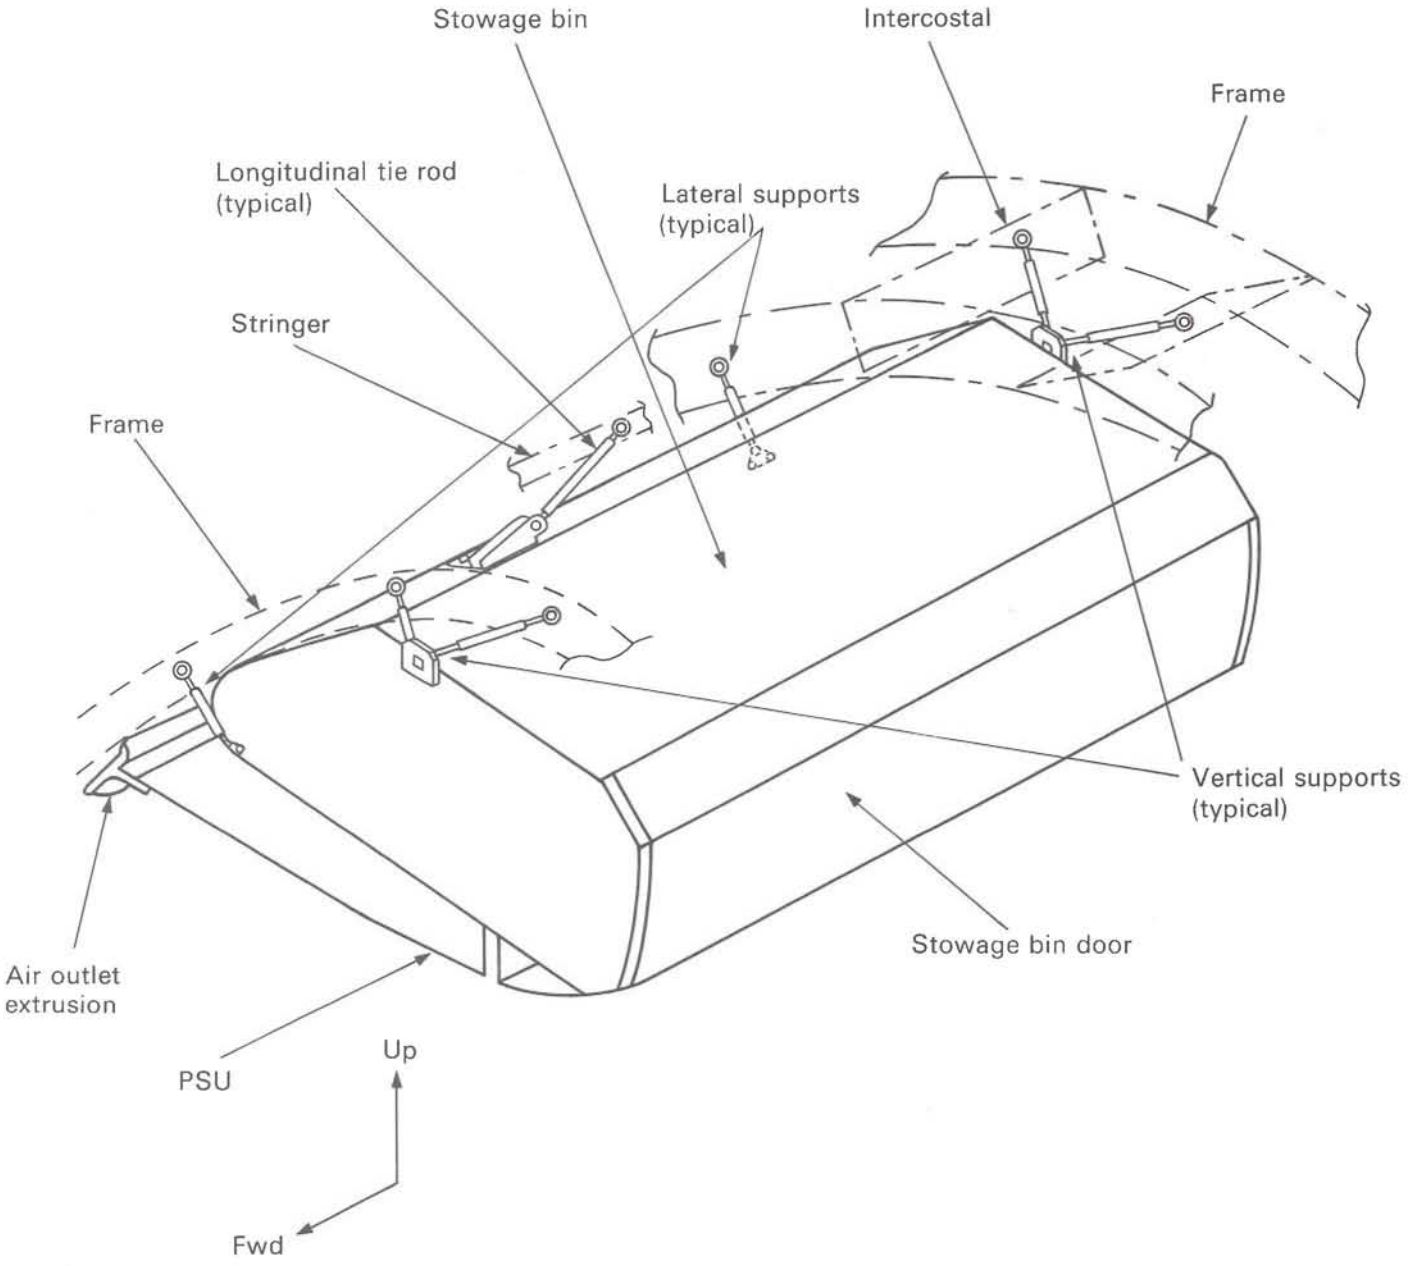
Appendix 3 Figure 5 Stowage bin attachments

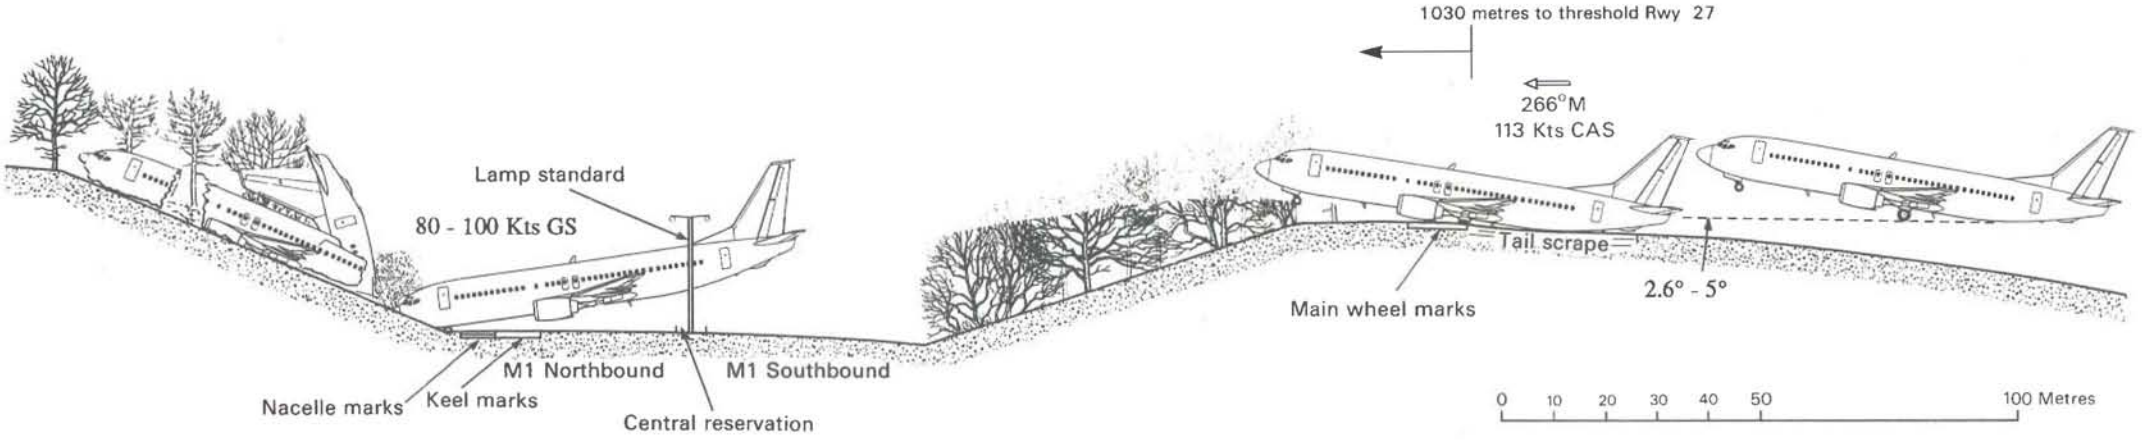
Appendix 3 figure 6 - Impact sequence

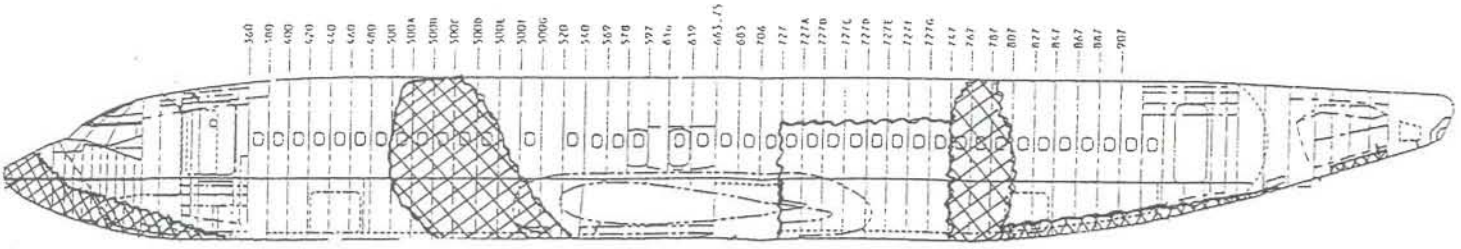
Appendix 3, figure 7 - Structural disruption

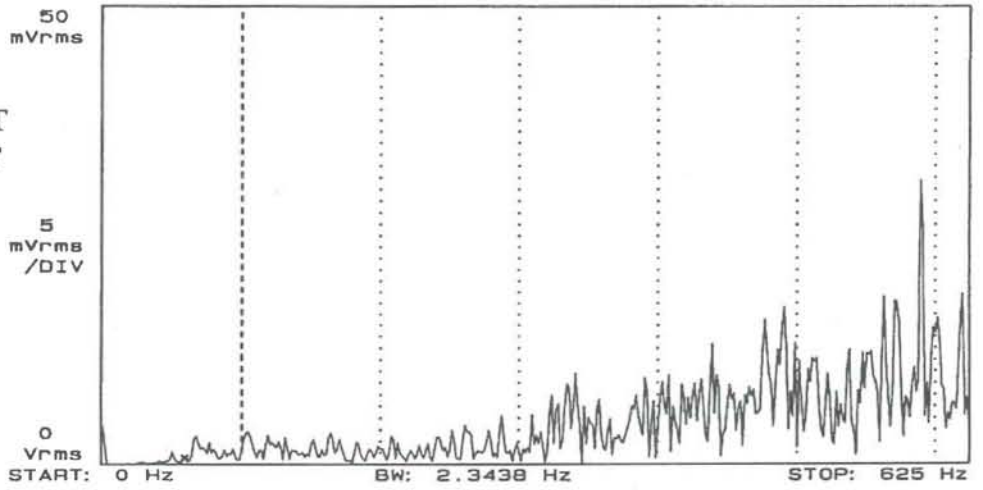
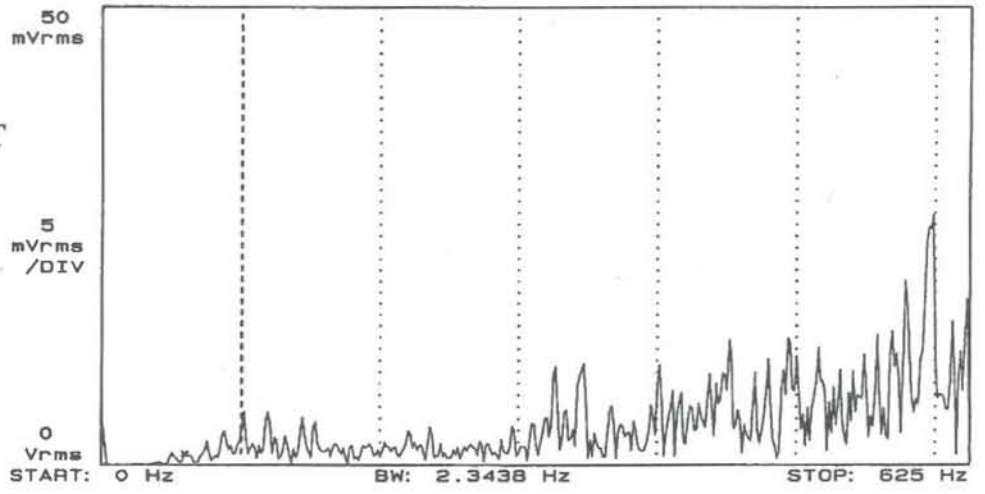
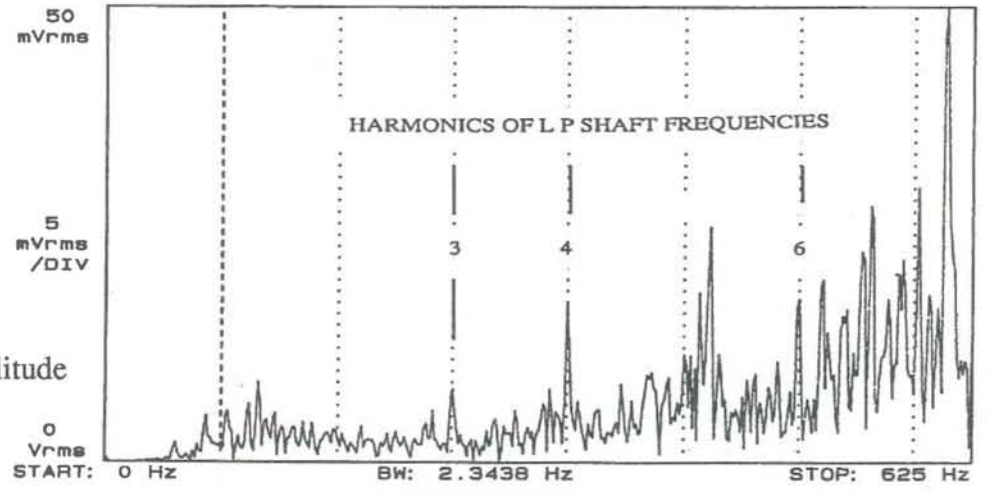
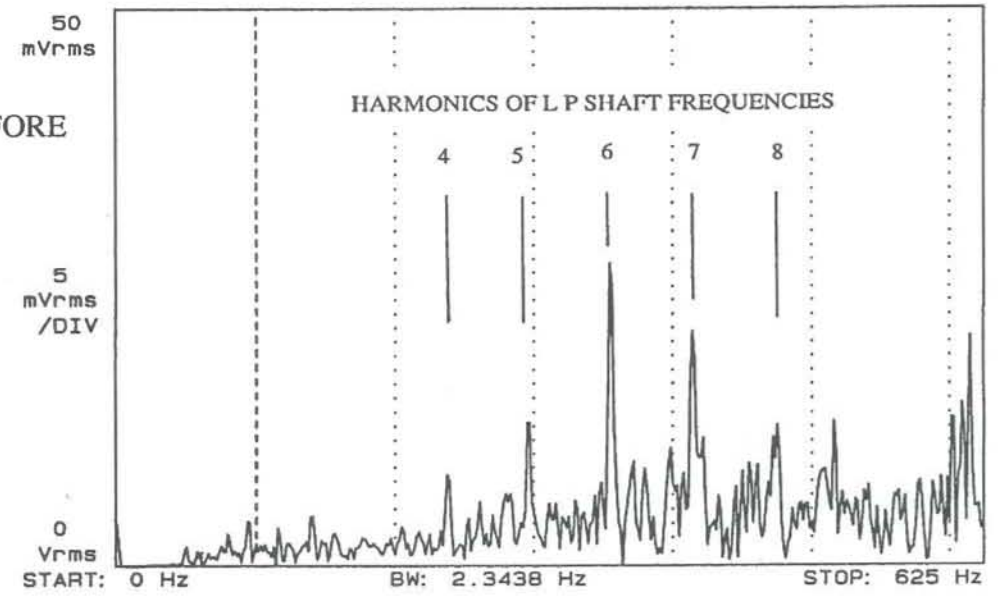
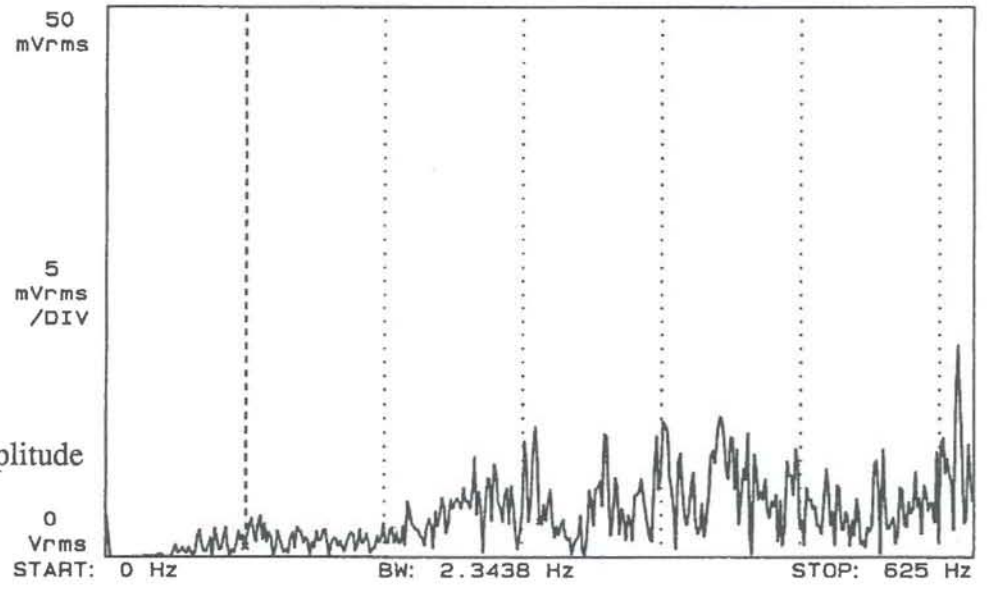
COMPARISON OF SIGNATURES BEFORE AND AFTER FIRST EVENT

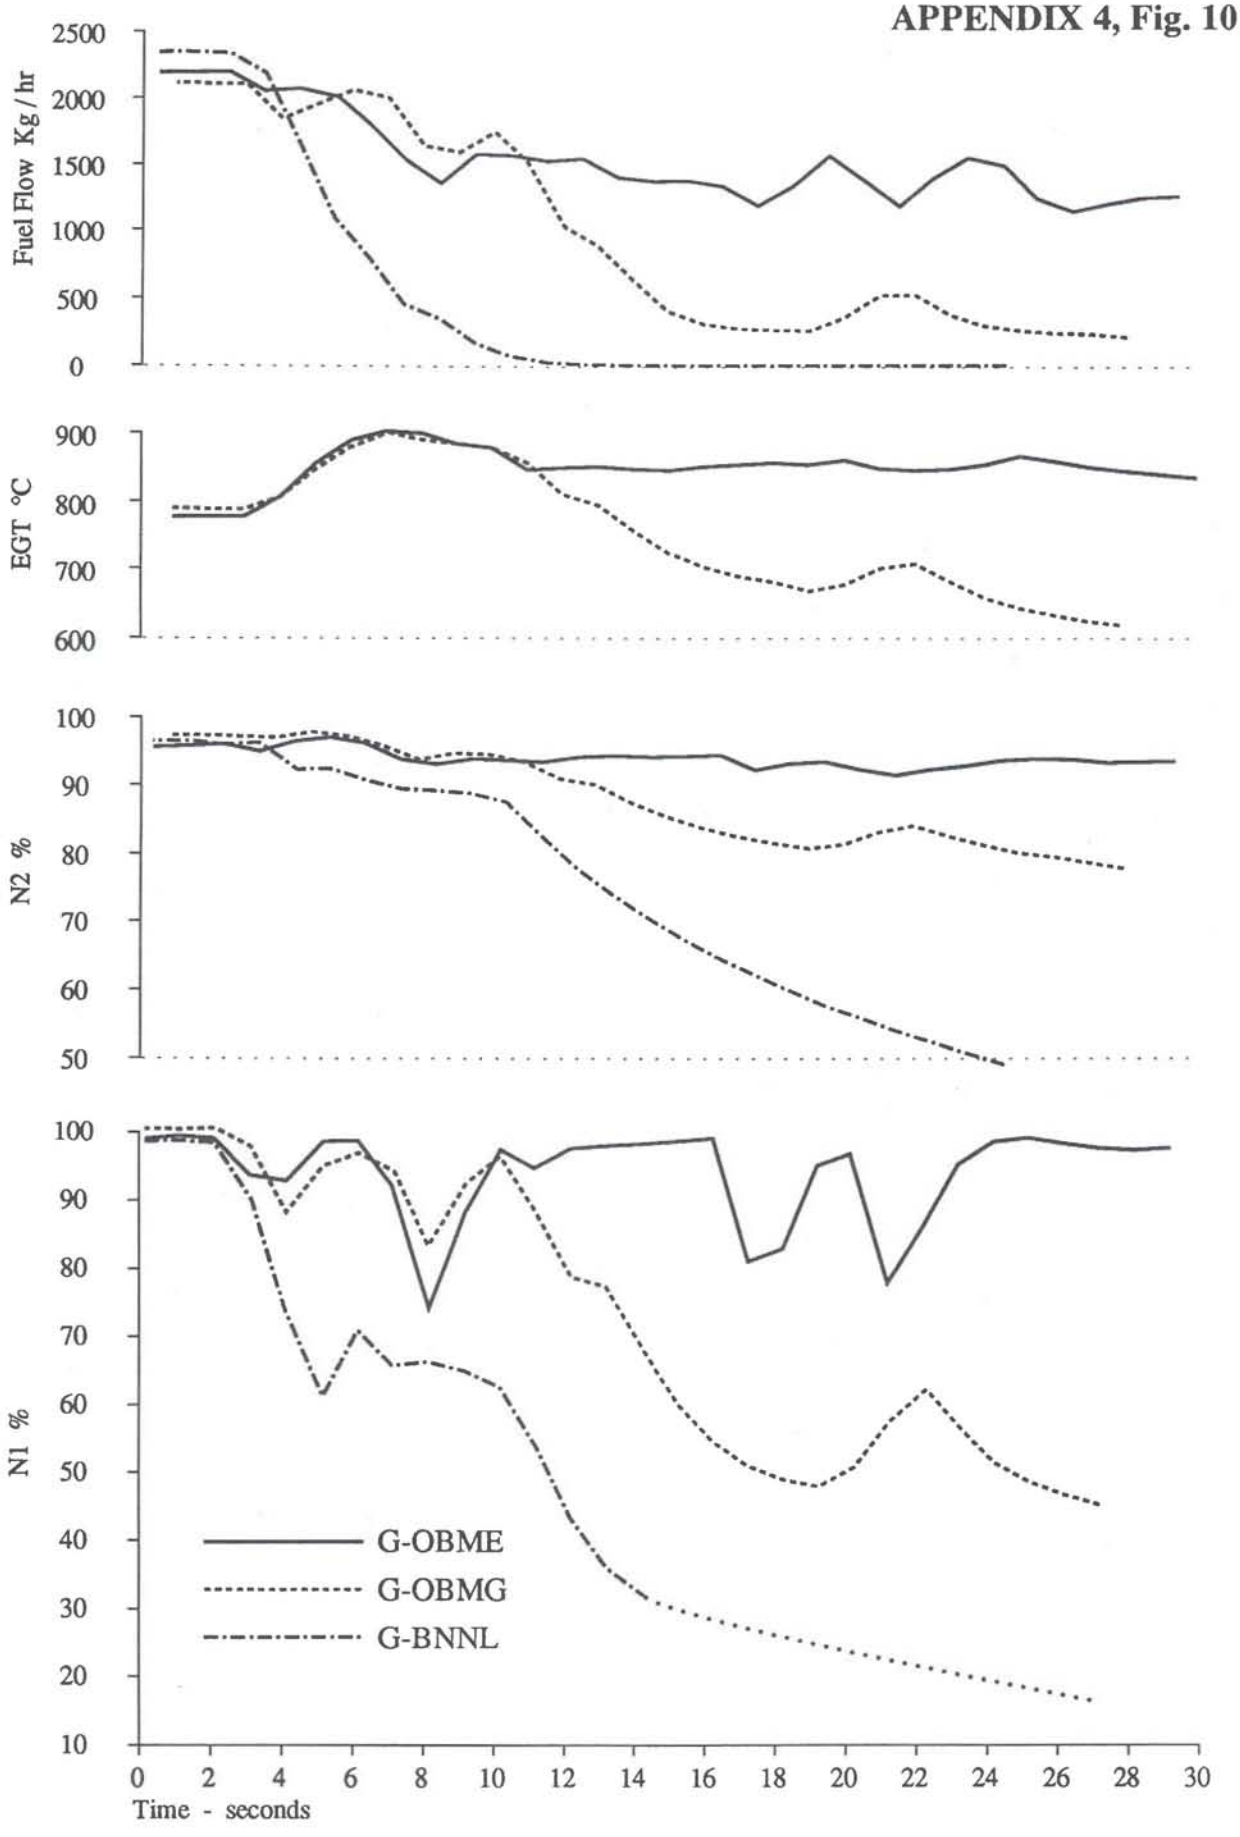
APPENDIX 4, Fig. 10

Comparison of engine parameter response following fan blade outer panel separation on three aircraft (G-OBME, G-OBMG, G-BNNL)

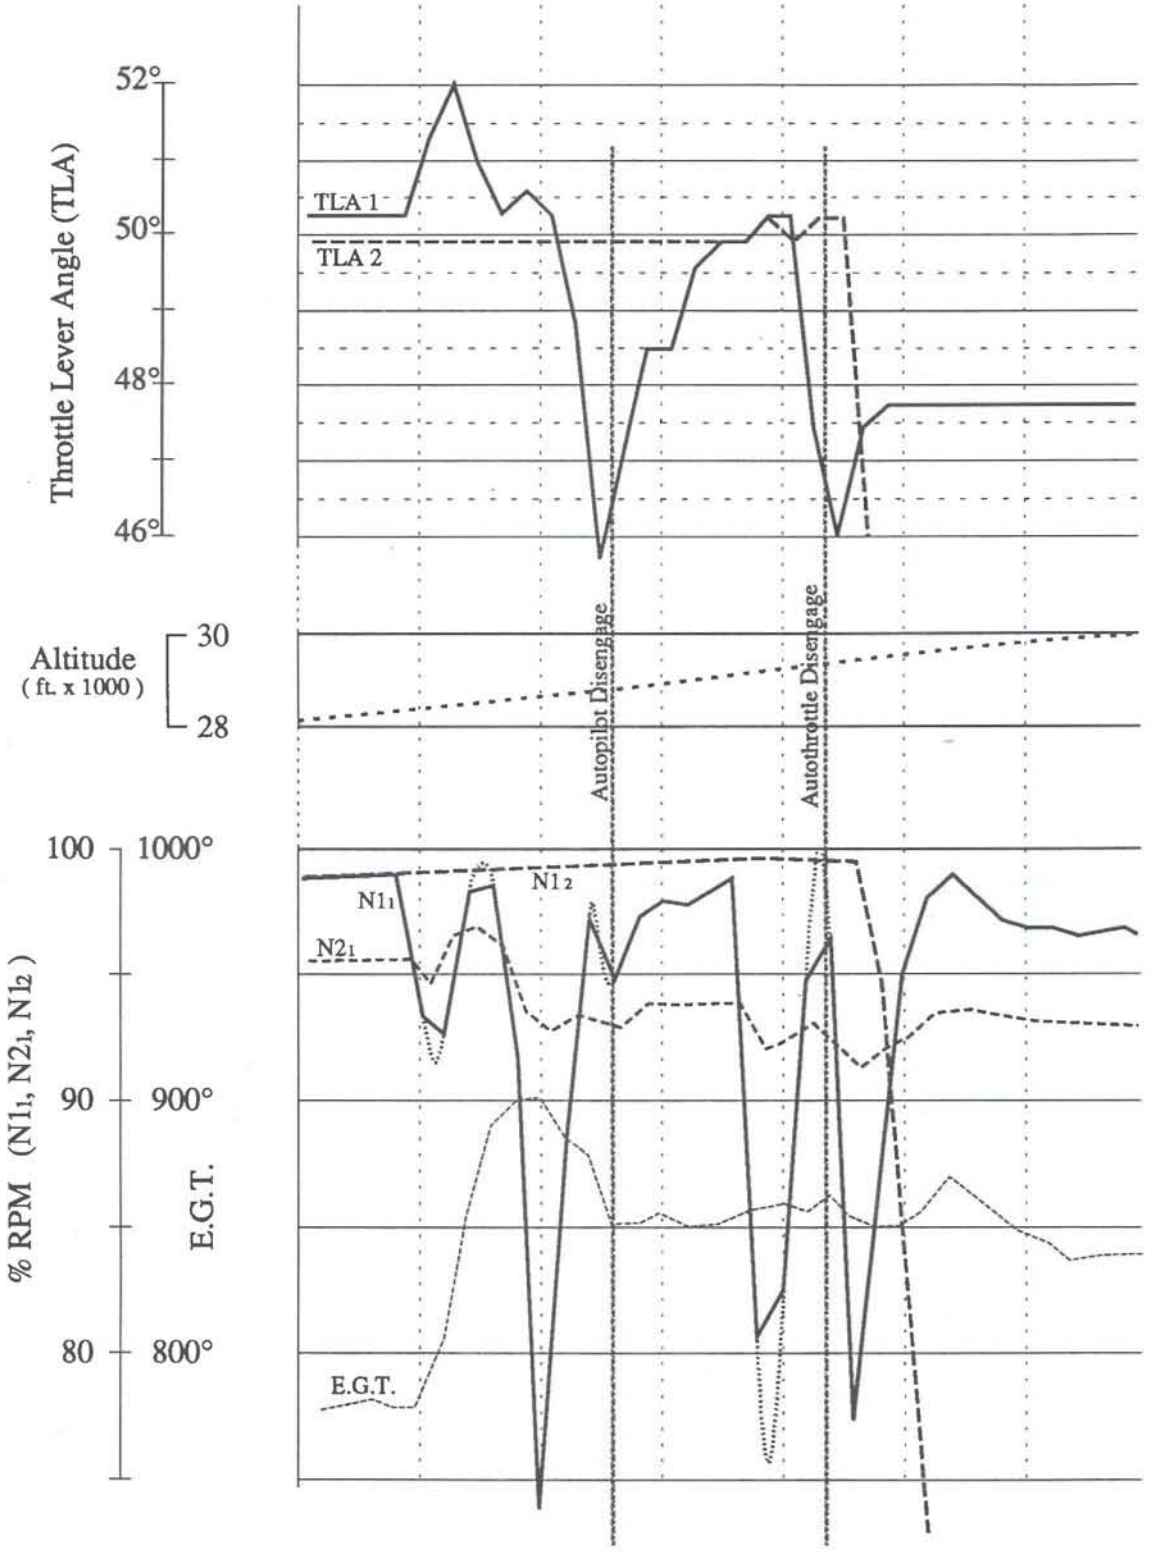
Variation of Throttle Lever Angle
related to engine parameters and altitude during Event 1
