CFM56-3

Aircraft Type and Registration:	Boeing 737-400, G-OBME
No & Type of Engines:	2 CFM 56-3C high by-pass turbo-fan engines
Year of Manufacture:	1988
Date and Time (UTC):	8 January 1989 at 2025 hrs
Location:	Kegworth, near East Midlands Airport, Leicestershire
Type of Flight:	Scheduled passenger
Persons on Board:	Crew - 8 Passengers - 117 + 1 infant
Injuries:	Crew - 7 (serious) Passengers - 47 (fatal). 66 + 1 infant (serious) 1 (minor) 4 (minor)
Nature of Damage:	Aircraft destroyed
Commander's Licence:	Airline Transport Pilot's Licence
Commander's Age:	43 years
Commander's Total Flying Experience:	13180 hours (of which 765 were on Boeing 737-300/400 types)
Information Source:	AAIB Inspector's Investigation under the Civil Aviation (Investigation of Accidents) Regulations 1983

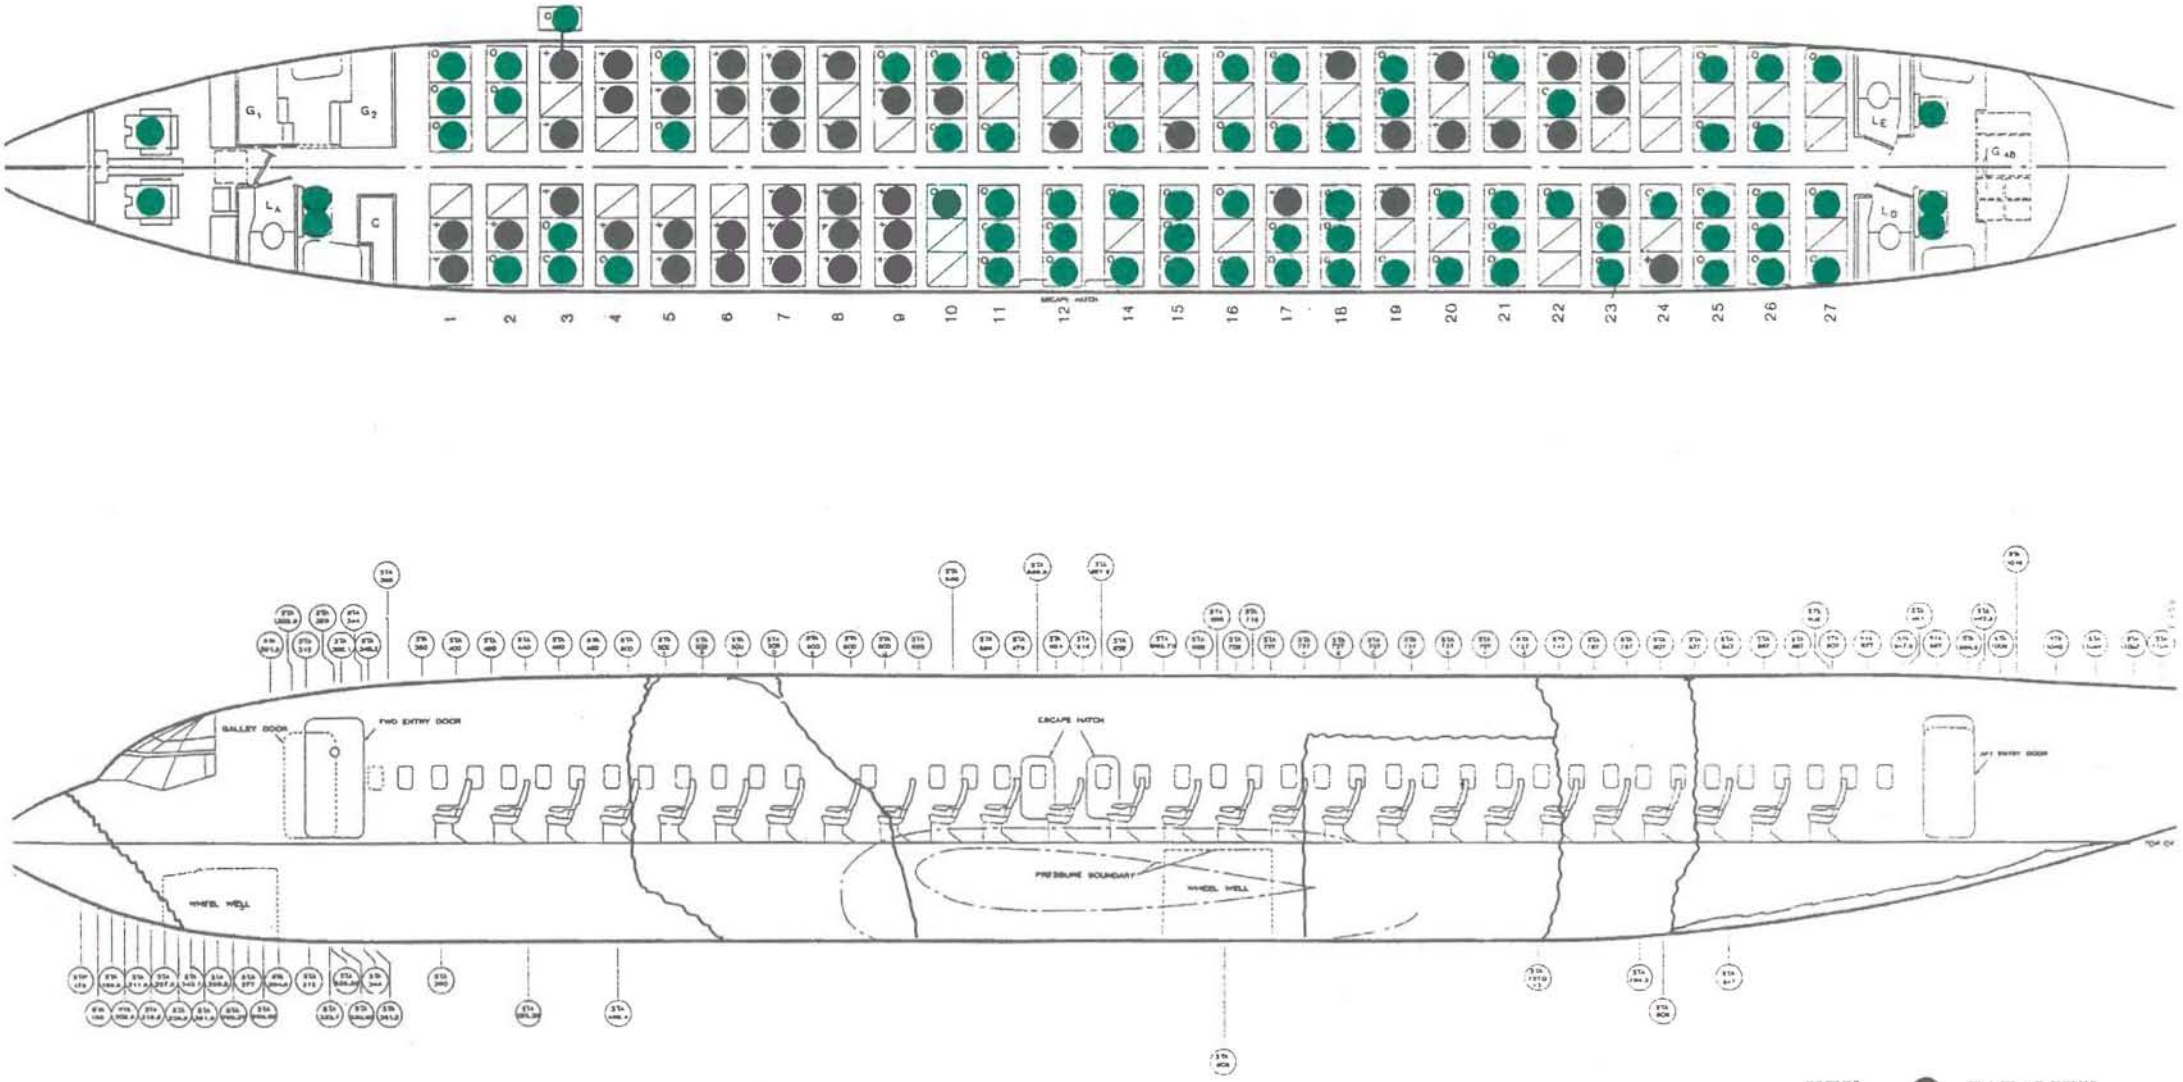
FIG 1: SHOWING SEAT POSITIONS OF FATALITIES AND SURVIVORS

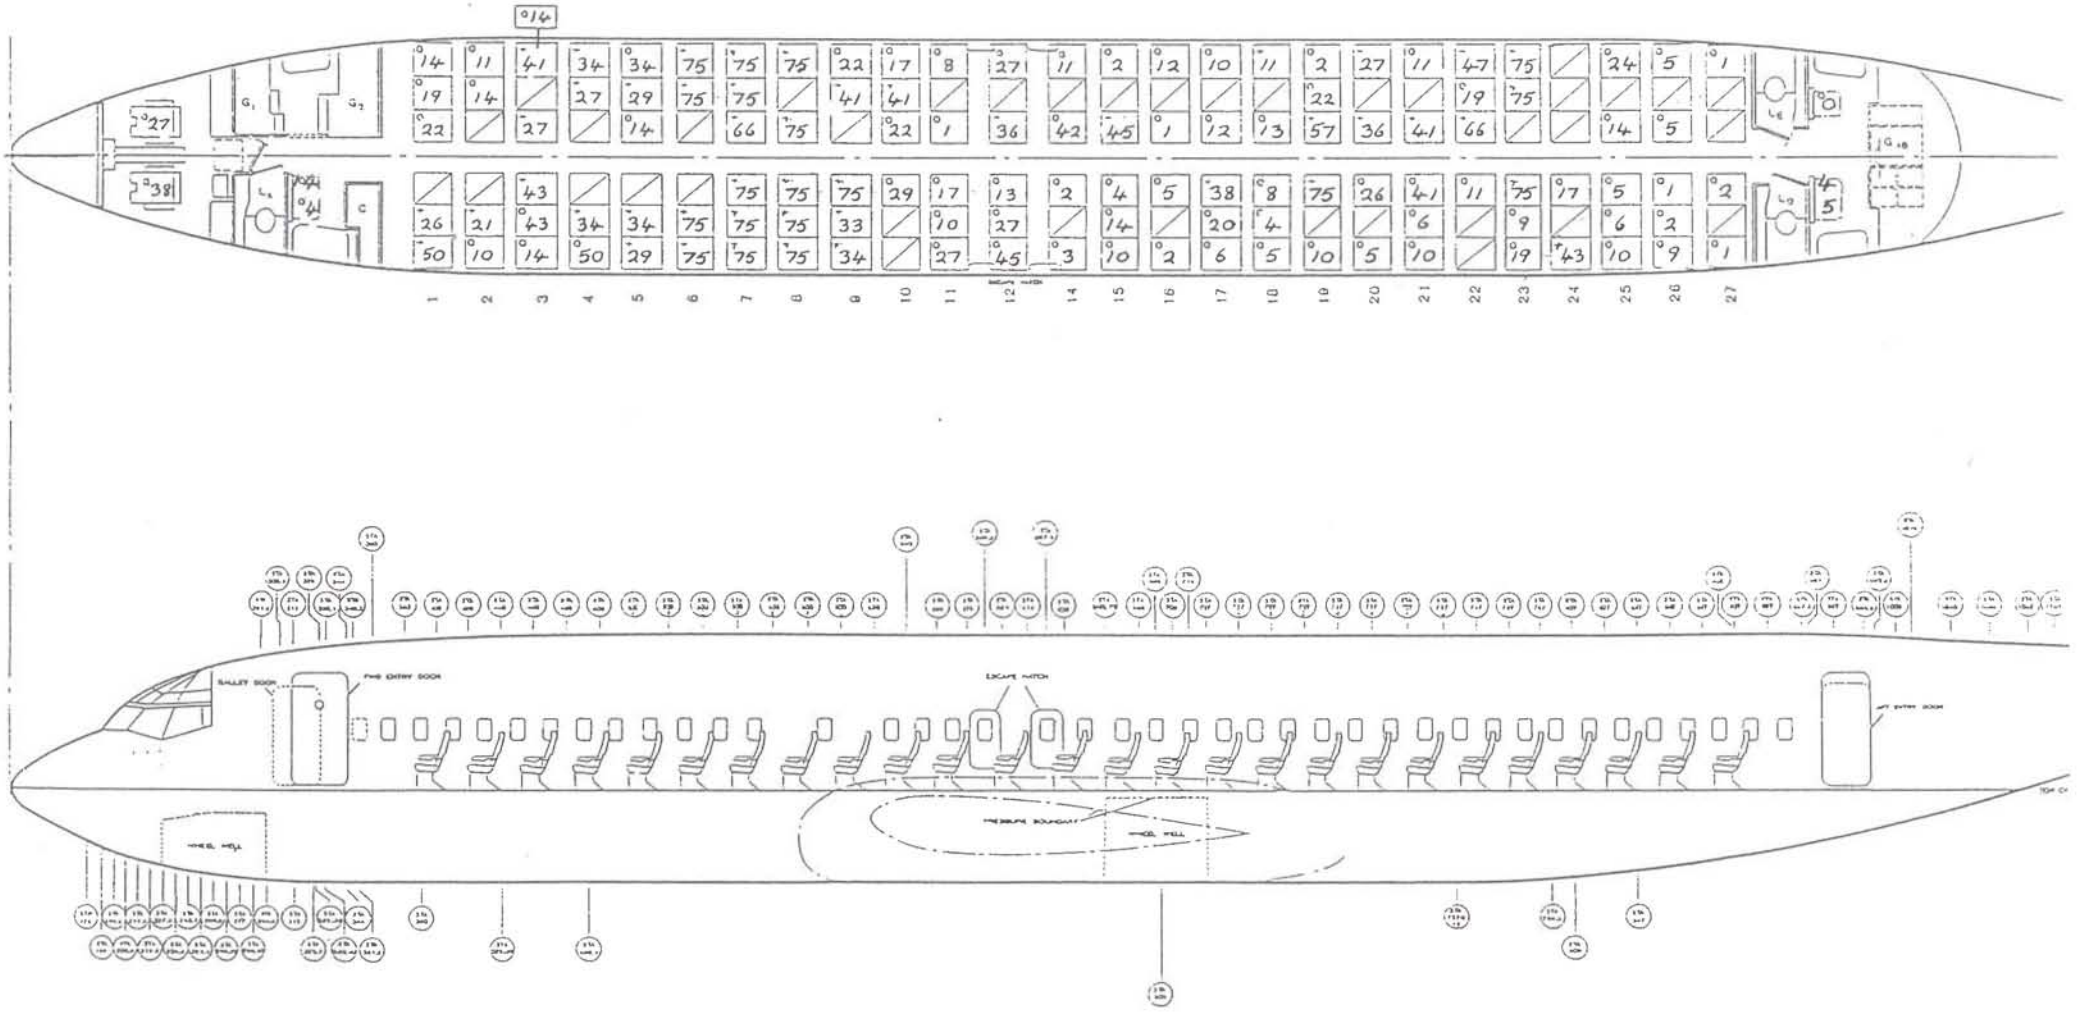
FIG 2: SHOWING INJURY SEVERITY SCORES FOR OCCUPANTS

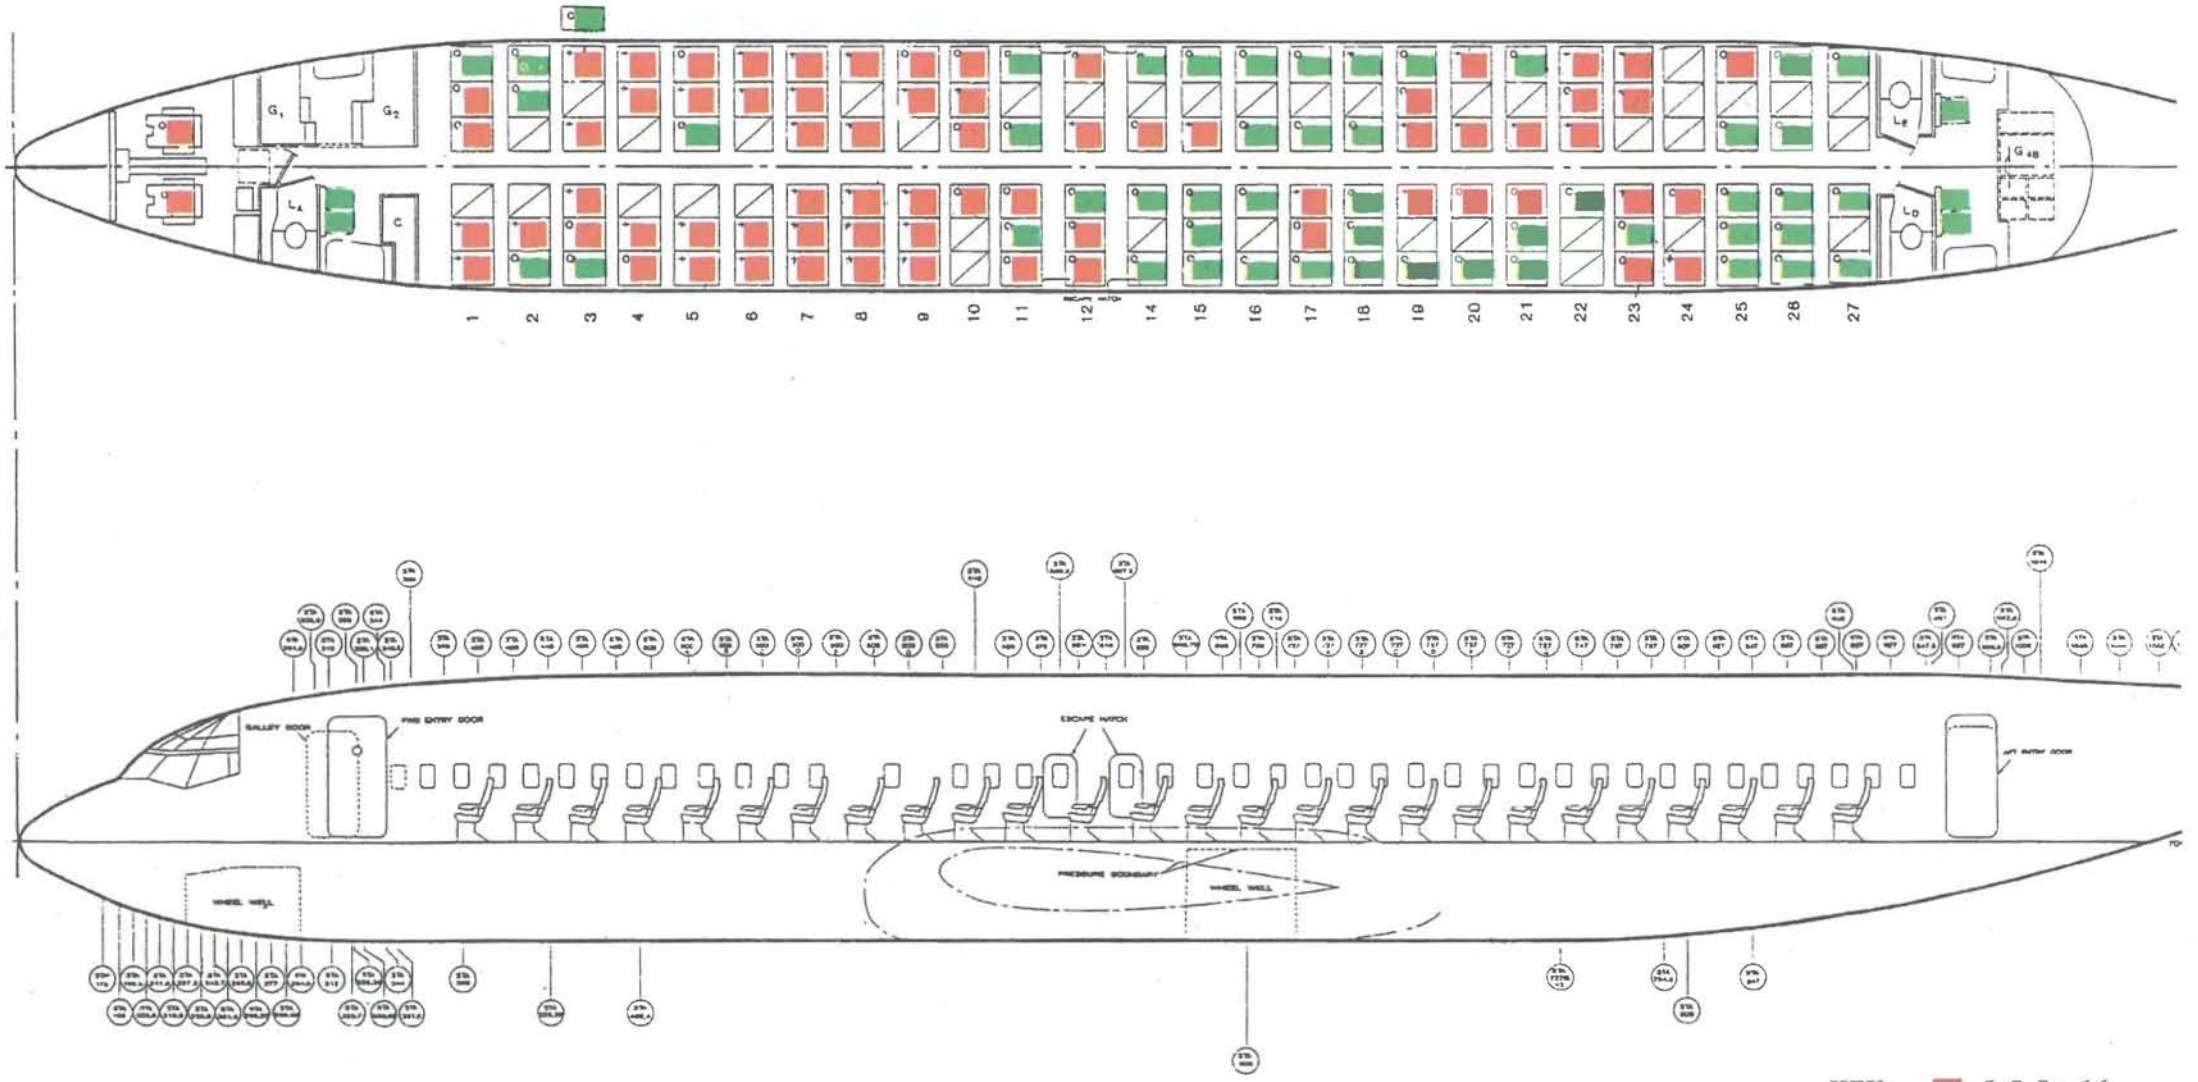
FIG 3: SHOWING DISTRIBUTION OF INJURY SEVERITY
