**Turkish Airlines DC-10 TC-JAV**  
**Report on the accident in the**  
**Ermenonville Forest, France**  
**on 3 March 1974**

ACCIDENT TO  
TURKISH AIRLINES DC-10 TC-JAV  
IN THE ERMENONVILLE FOREST  
ON 3 MARCH 1974

FINAL REPORT

February 1976

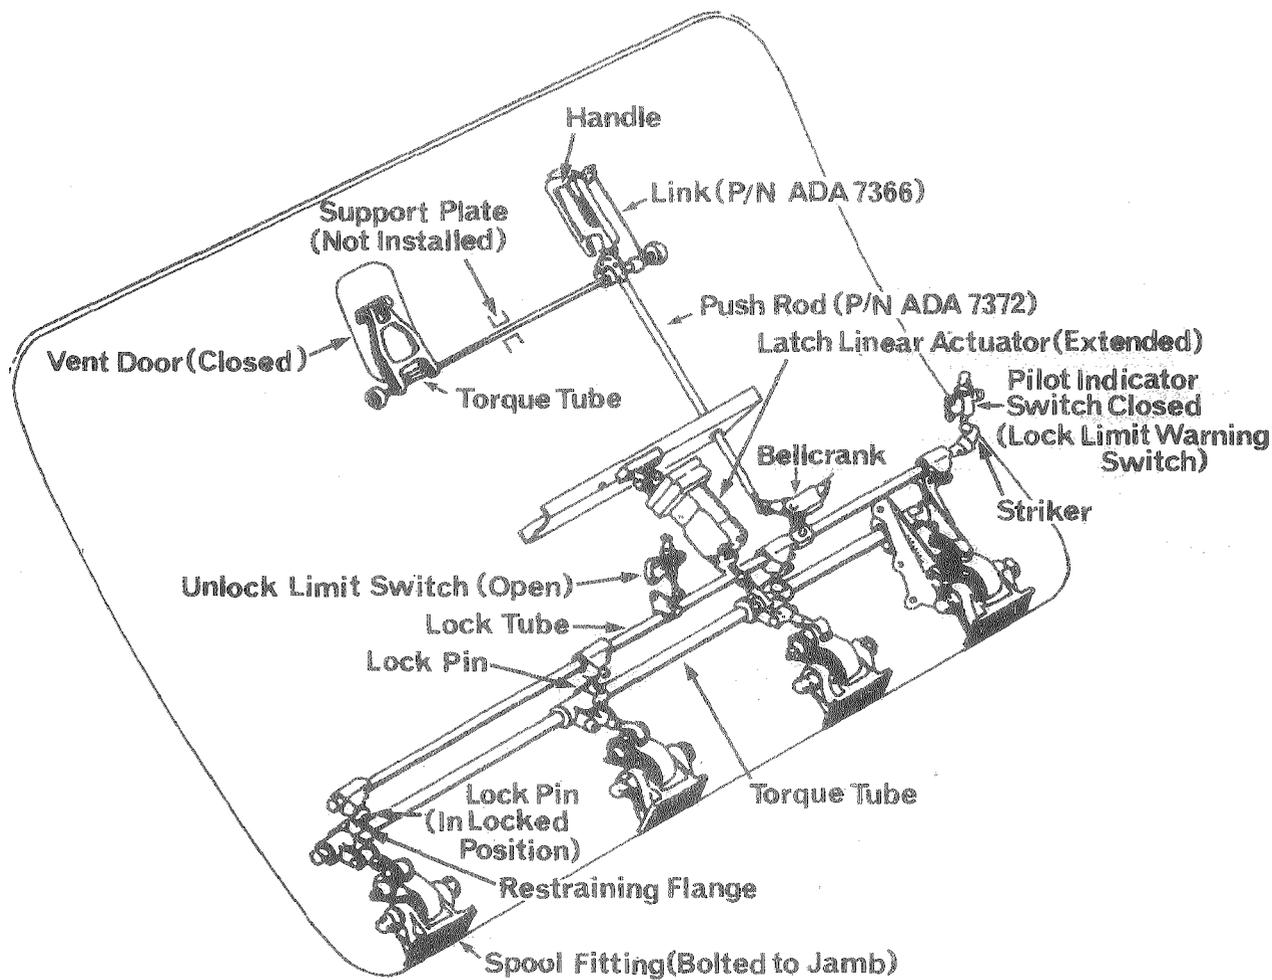
**FIG. 6**

This closure was possible only because of deformation of the mechanism providing control transmission for the operation of the lock tube. The principal deformation affected the vent door shaft. The additional support plate specified by SB 52-37 (fig 6) was designed precisely to prevent such deformation.
